# **Retrofit Dowel Bars in Jointed Concrete Pavement— Long-Term Performance and Best Practices**

Thomas Burnham<sup>1</sup> and Bernard Izevbekhai<sup>2</sup>

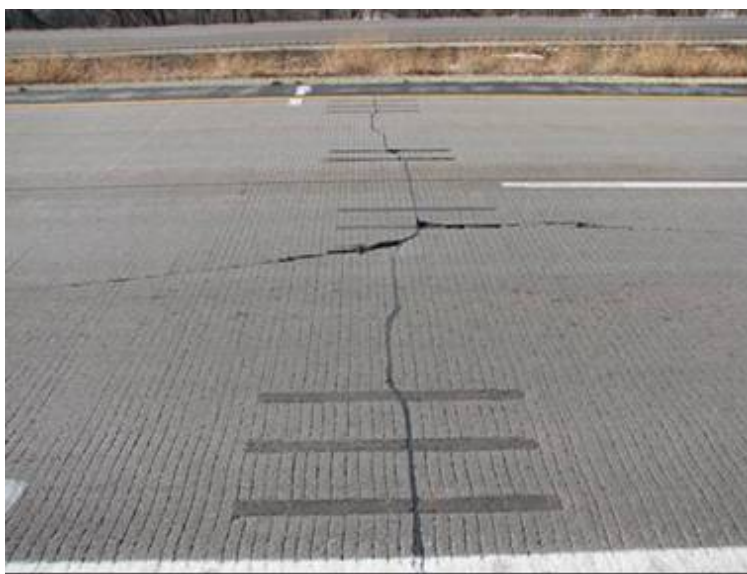
The retrofit dowel bar test sections on TH 52 were installed in 1994, and therefore to date have had over 14 years of exposure to traffic (heavy commercial average daily traffic [HCADT] = approximately 2,100)(6) and weather. Recent site visits took place in October 2006 and February 2007. During those visits, surface distress on the test sections was recorded as being minimal. Faulting of the transverse mid-panel cracks remains very low. There are a small number of distressed retrofit dowel bar groups, predominantly affected by longitudinal cracking in the panels (see Photo 1). Despite early concerns about shrinkage cracking in the many of the slots (unpublished report by Mn/DOT Geology Unit), there is little deterioration of the backfill mortar after 14 years of service. Photo 2 shows retrofit dowel bar slots with Mn/DOT 3U18 backfill mortar in very good condition. Several slots with PMQP backfill mortar experienced a loss of material of approximately 13 mm (0.5 in.) below the surface, however the integrity of the remaining material in the slot appeared to be sound (see Photo 3).

**Photo 1. Distress in TH 52 retrofit dowel bars caused by longitudinal panel cracks.**

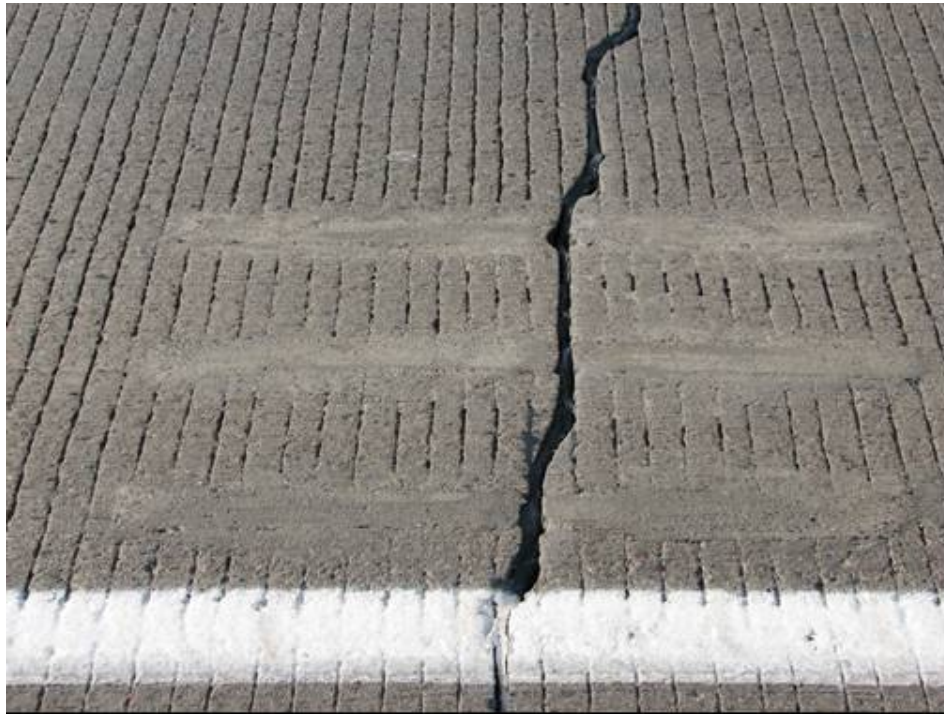
**Photo 2. TH 52 slots with Mn/DOT 3U18 backfill mortar after 13 years.**

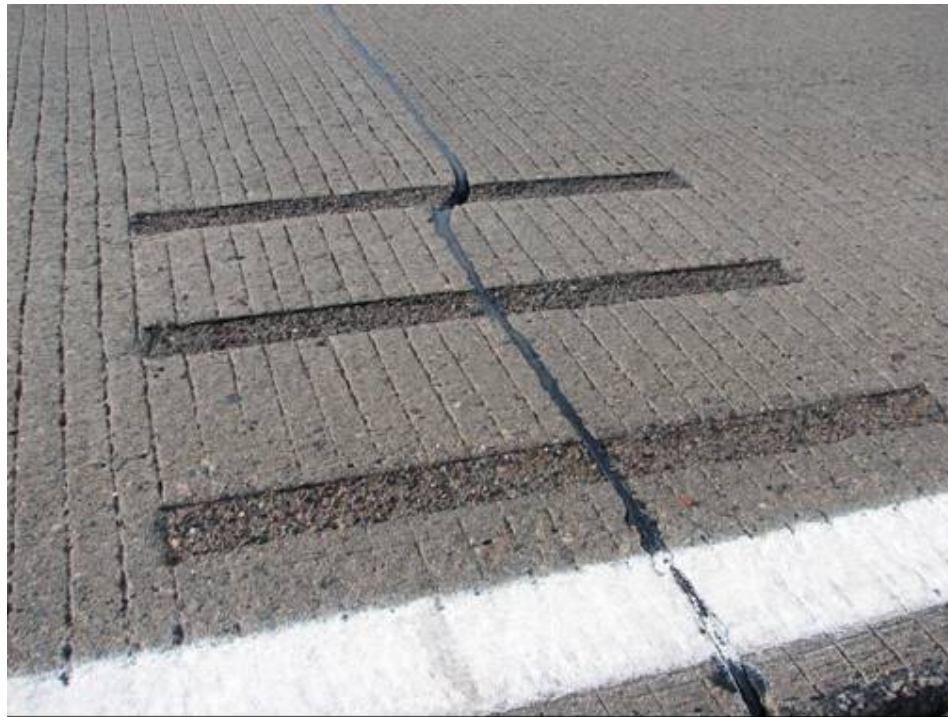
**Photo 3. Loss of PMQP mortar near surface of slots on TH 52.**

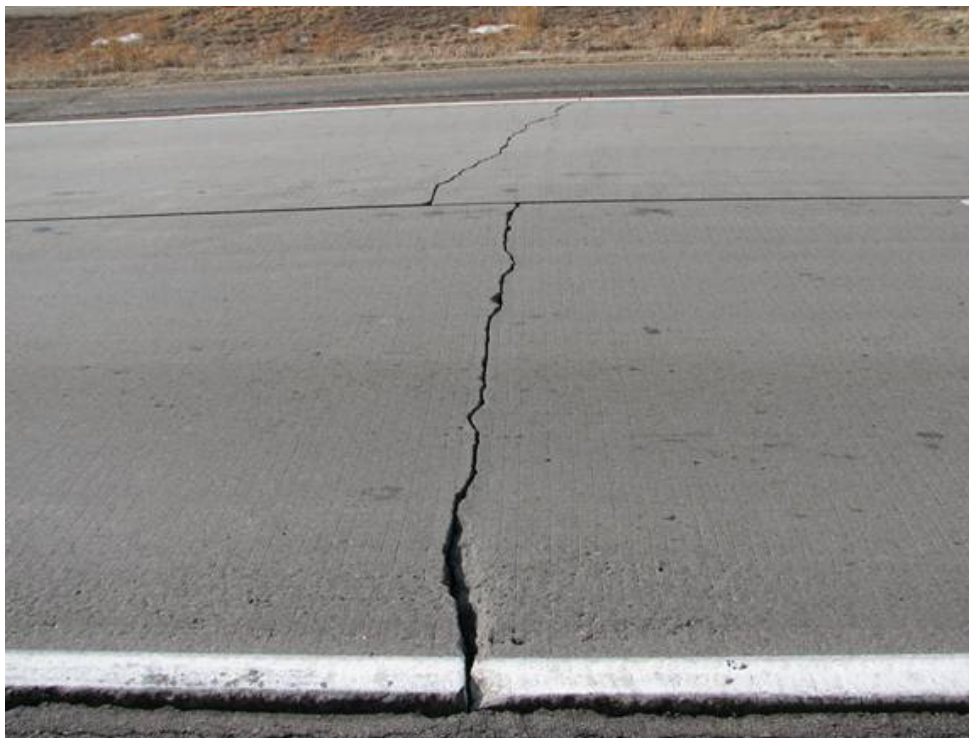
With regards to the various dowel patterns, it seems the performance in terms of ride quality at year 13 is insensitive to the number and length of the retrofit dowel bars as they were designed in this project. The benefit of retrofitting dowels across mid-panel cracks on TH 52 can clearly be seen by observing the faulting that occurred on a number of nearby unsealed mid-panel cracks that had not received retrofit dowel bars (see Photo 4).

**Photo 4. Faulted mid-panel cracks without retrofit dowels on TH 52.**

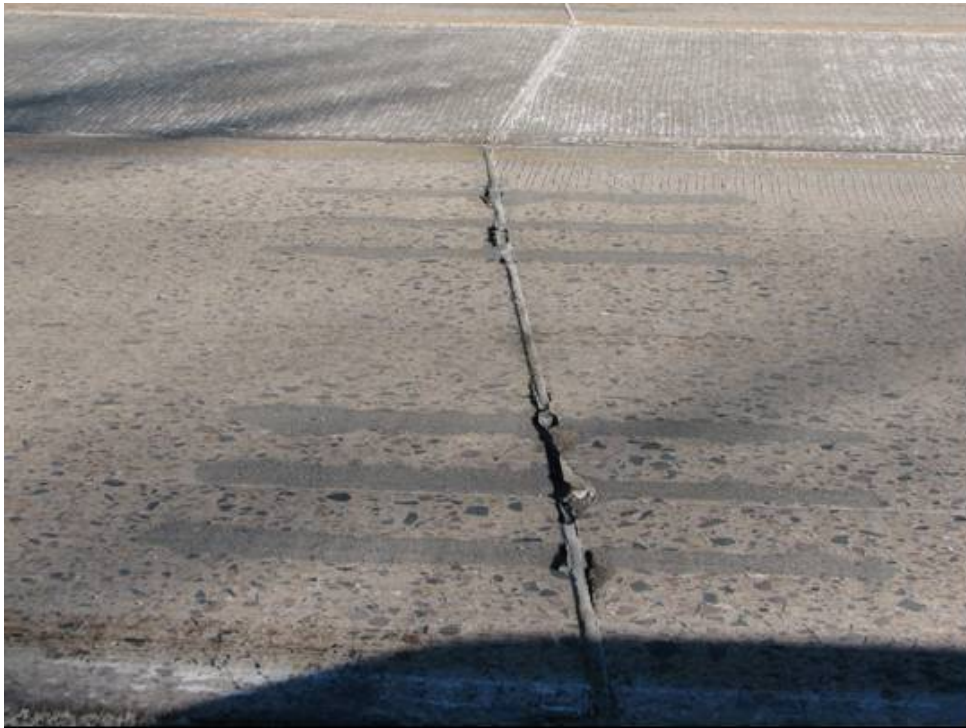
The retrofit dowel bars on TH 12 were installed in 1996, and therefore have been exposed to over 12 years of traffic (HCADT = approximately 600)(6) and weather. Recent site visits took place in October 2006 and February 2007. During those visits, minor surface distress on the retrofit dowel bar slots was noted to occur predominantly near the joints (see Photo 5). The distresses might be linked to the slot milling process, when material near the joint

was weakened. Otherwise, there was little deterioration of the Mn/DOT 3U18 backfill mortar after 10 years of service.

**Photo 5. Backfill mortar distress near joints on TH 12.**

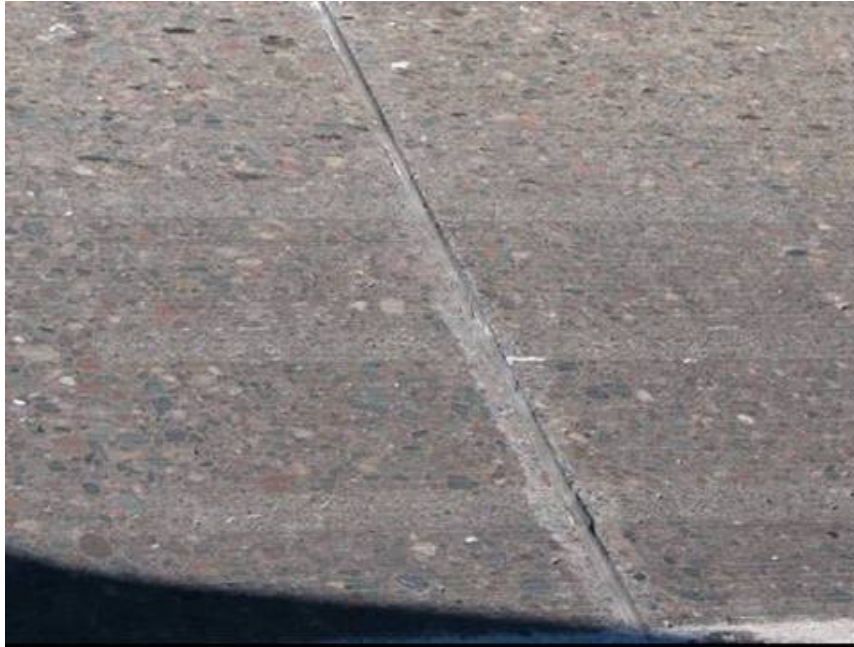
**Photo 6. TH 23 slots with Mn/DOT 3U18 backfill mortar after 8 years.**

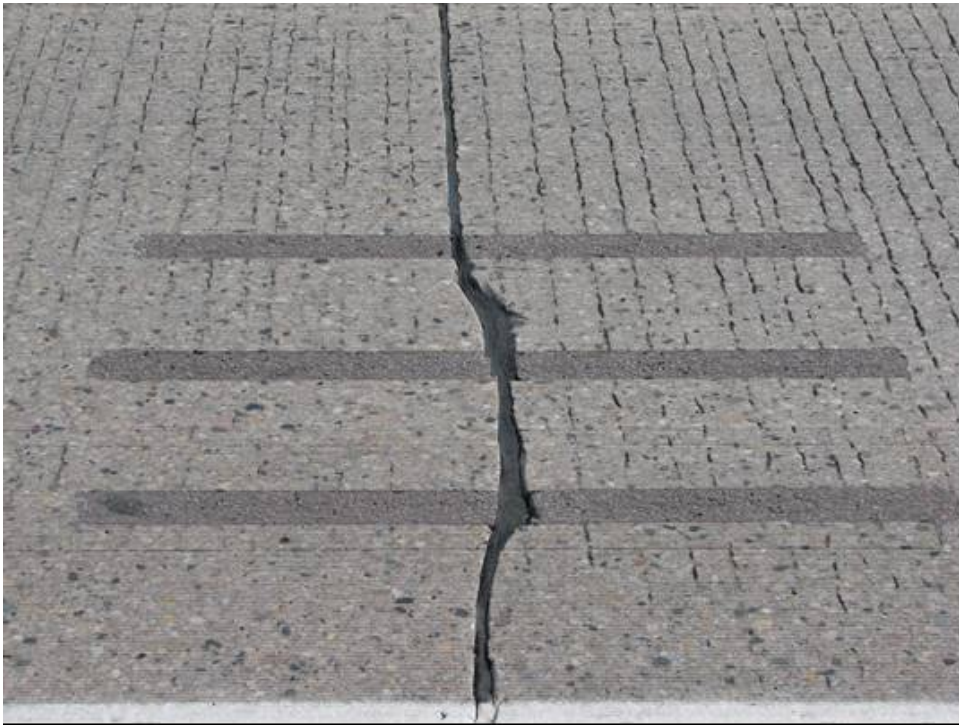
**Photo 7. Typical condition of I-90 slots with PMQP backfill mortar after 7 years.**

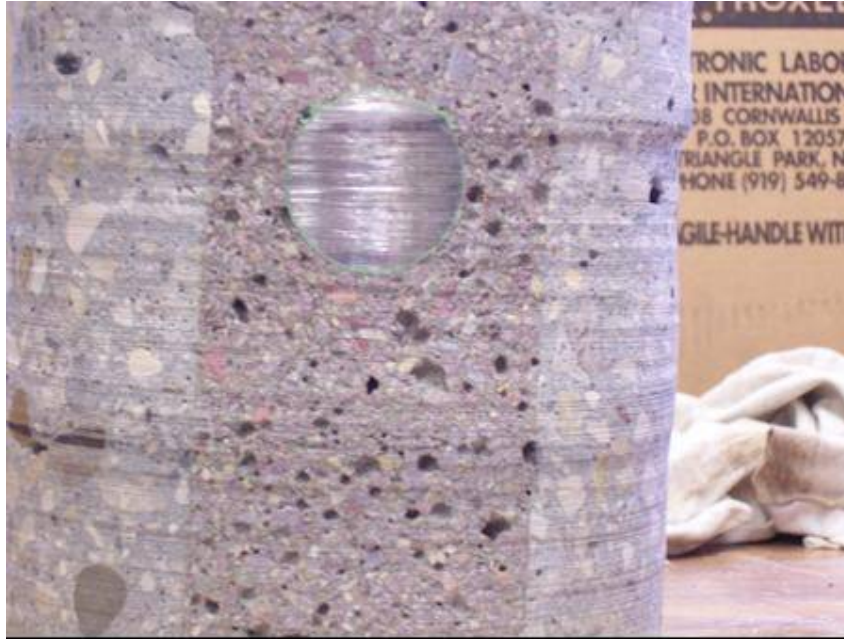
A retrofit dowel bar project was constructed in 1994 on Minnesota TH 59. A contractor test site was constructed and the specified cores were taken and tested. Many of the core samples did not attain the required ASTM 928 prescribed strength. The cores also revealed severe honeycombing. This is shown in Photo 9. These results necessitated a switch from one approved backfill product to another.

**Photo 9. Core from TH 59 test site showing honeycombed retrofit mortar.**
