Historic Concrete Investigations at Pointe du Hoc, Normandy, France

Toward interpretation and preservation of an important site

BY TANYA WATTENBURG KOMAS AND RICHARD BURT

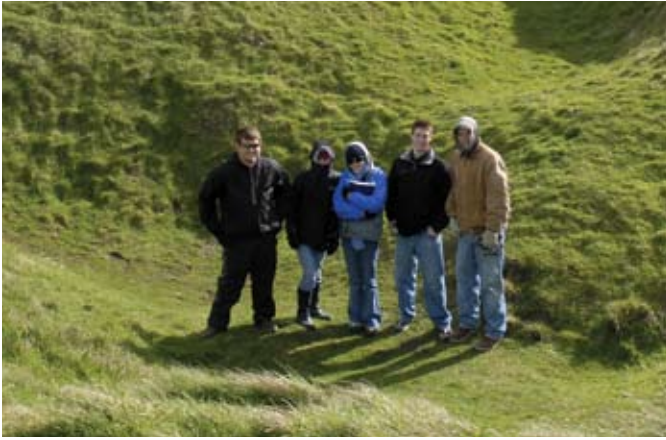
Fig. 3: Students standing at the base of a bomb crater

Starting April 25, 1944, the site was subject to intensive bombing from medium and heavy bombers dropping 225, 450, and 900 kg (500, 1000, and 2000 lb) bombs. The easy identification of the Pointe resulted in accurate attacks during daylight raids. Destruction of the site continued on D-Day when the site was subjected to naval bombardment from several ships, including the 355 mm (14 in.) guns of the USS Texas. Photographs taken after the battle show the site virtually covered with bomb and shell craters that are still clearly present today (Fig. 3).

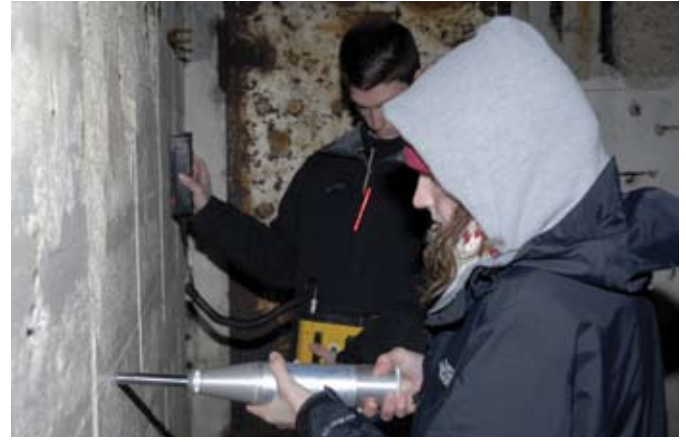
Fig. 4: Inside the observation post, Courtney Sheehan tests relative concrete strength with a Schmidt (rebound) hammer while Chad Golden uses a cover meter to determine location, size, and cover of embedded reinforcing

use of newer equipment with more traditional units such as the Schmidt hammer (Fig. 4).

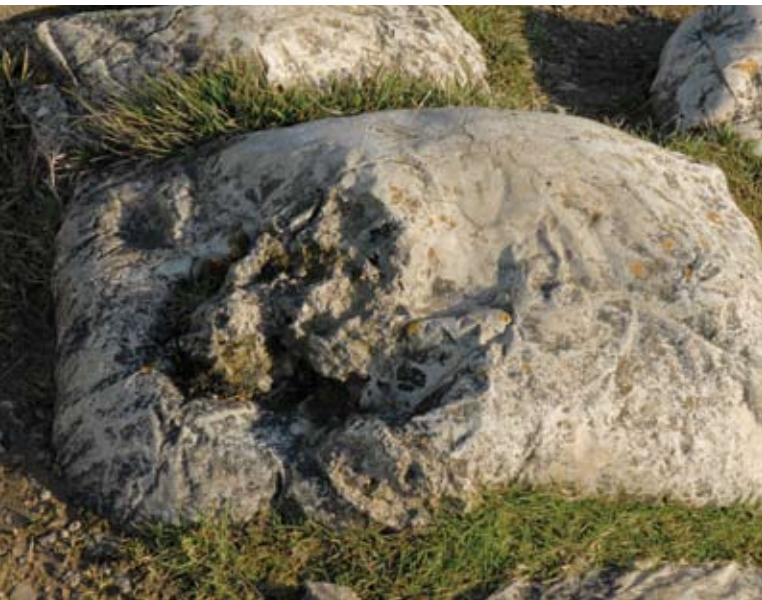
Fig. 5: Cement that was never used as a result of the D-Day invasion. The form is that of the sack in which the cement cured after having been left on the ground after D-Day

There have been three components to the concrete research to date, including laboratory testing, historic document research, and on-site testing. Laboratory tests were completed in December 2006 at CTLGroup, Chicago, IL. CTLGroup donated the use of its laboratory facilities and allowed the faculty from CSU Chico to work with its professional personnel to conduct laboratory testing of concrete and cement samples from the Pointe du Hoc site. The tests were undertaken to determine the mixture proportions and compressive strengths of two samples of concrete from different structures built at different times. Tests were also performed to determine the cement composition from a sample obtained from a hardened sack of cement that remained on the site from the date of original construction. The cement appears to have been intended for use in completing a new concrete block casemate that was destroyed by a bomb prior to completion (Fig. 5 and 6). The combined tests revealed similarities and differences between the concrete samples.

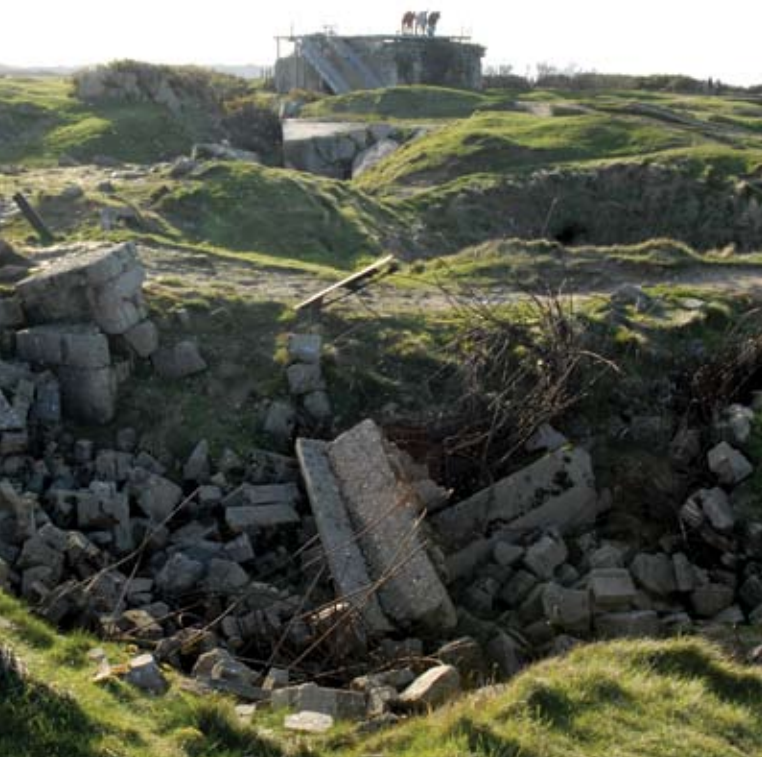
Fig. 6: Casemate that appears to have been under construction at the time of the D-Day invasion and was destroyed by a bomb prior to completion. The sack of hardened cement in Fig. 5 sits nearby

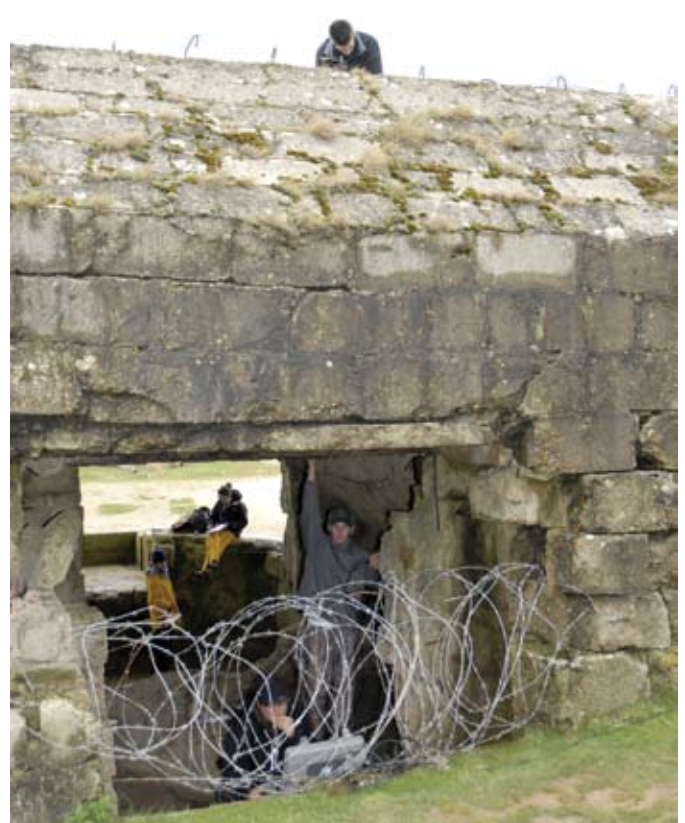
Fig. 7: Chad Golden (on top of the casemate) holds a transmitter that is sending ultrasonic pulses through the approximately 2 m (80 in.) of concrete to where Robert Hostettler (inside) is holding the receiver. Andrew Billingsley (seen through the barbed wire) is running the test data via a field-ruggedized computer on the velocity of the sound waves to determine soundness of the concrete

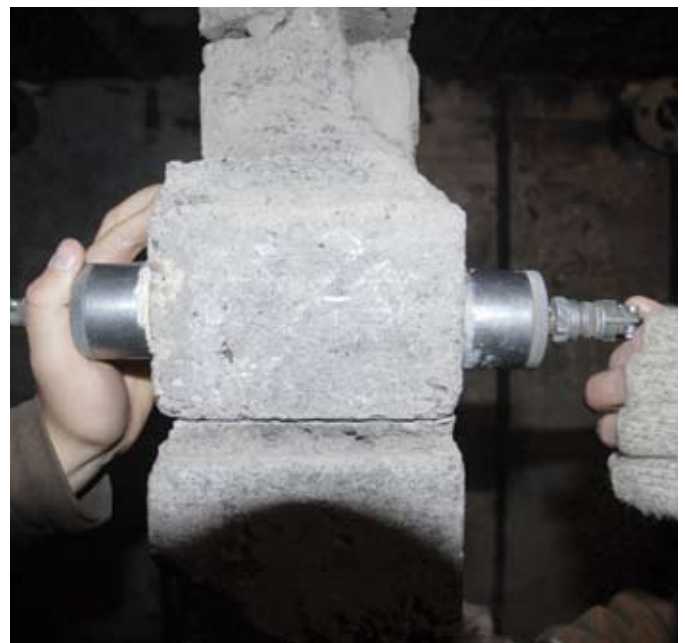
Fig. 8: Close-up of ultrasonic pulse velocity test on an observation post interior wall with two-sided access

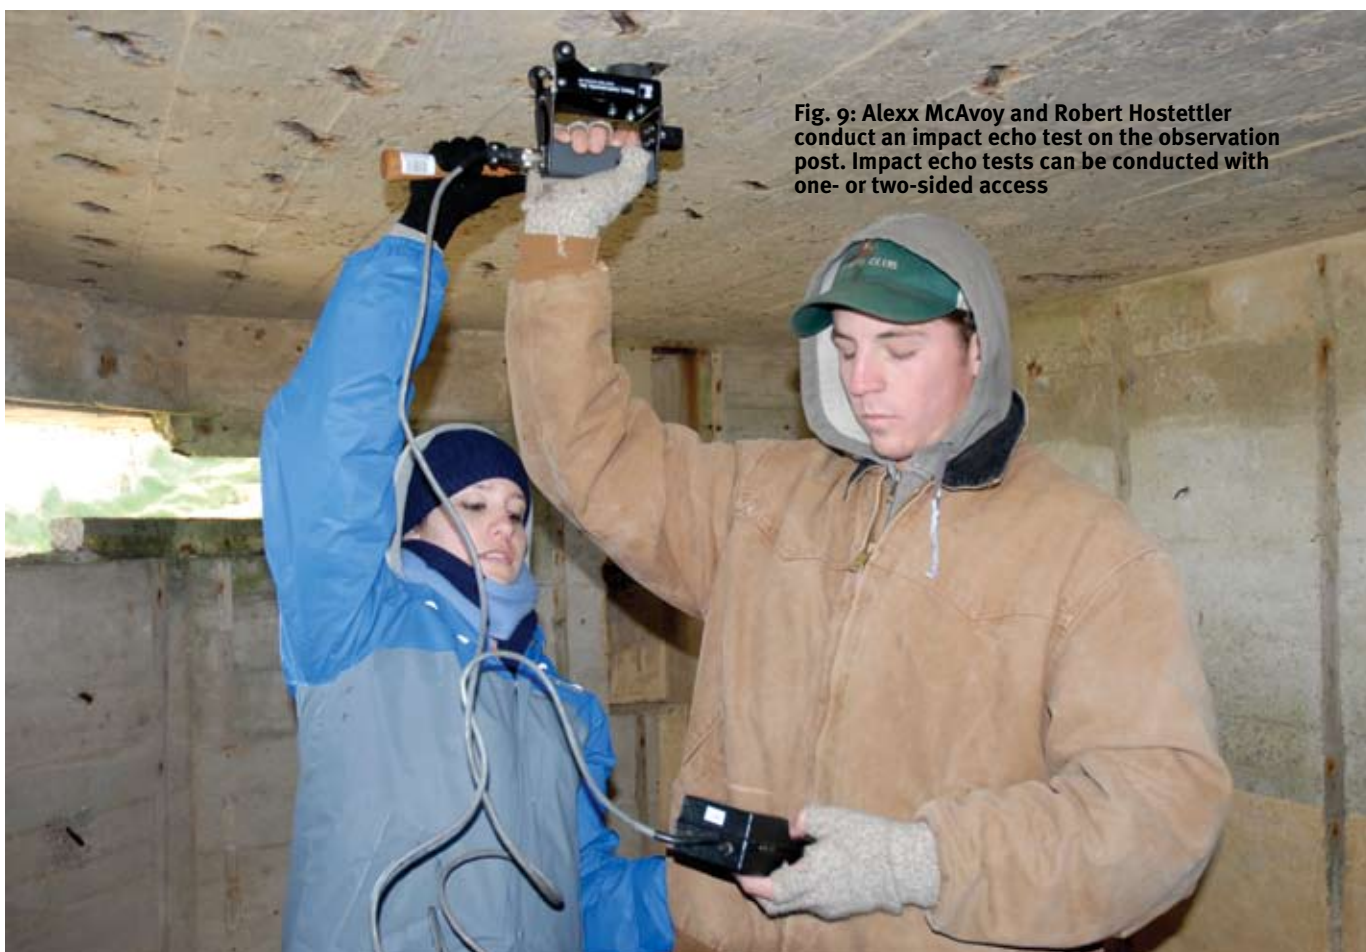
Fig. 9: Alexx McAvoy and Robert Hostettler conduct an impact echo test on the observation post. Impact echo tests can be conducted with one- or two-sided access
