# Evaluation of RAC-O-HB Project SAC 99-0.8/2.8

**Report Number: CP2C- 2007 - 101**

**November 1, 2007**

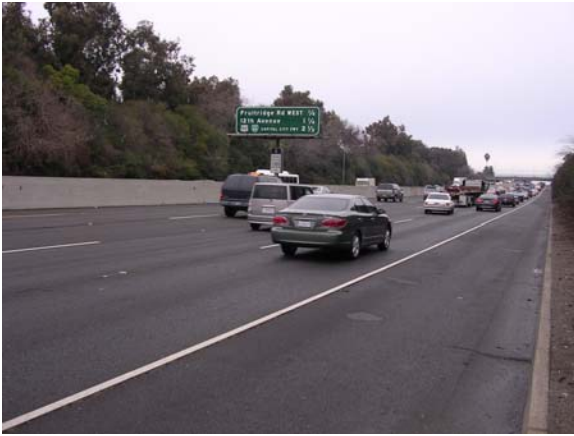
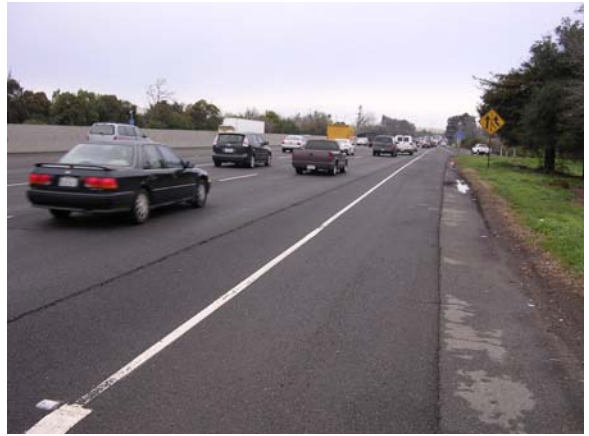
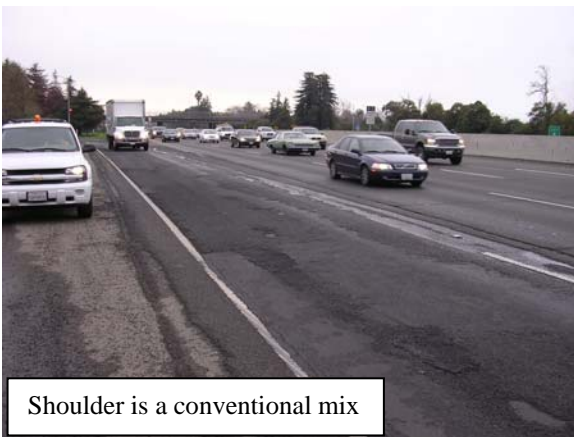
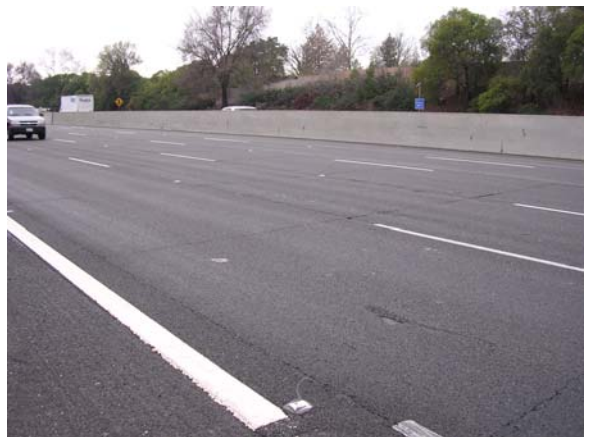
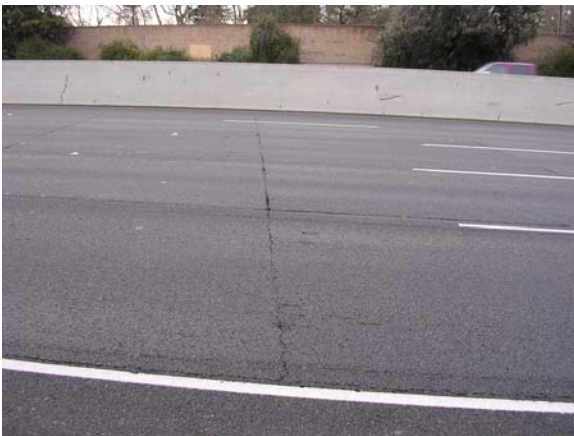
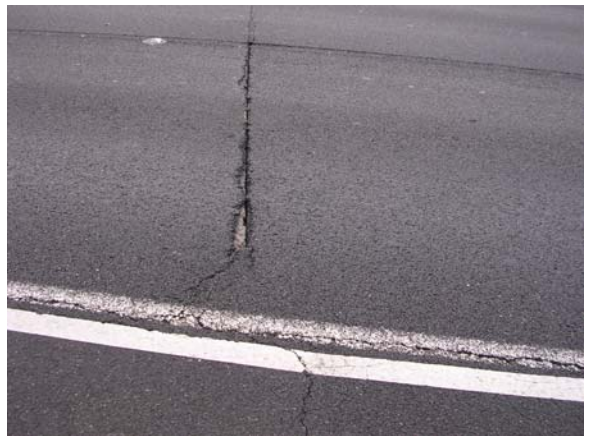
## Selected Photos from the SAC-99 Project (March 1, 2007)

- Despite the lack of surface preparation of the existing concrete pavement, the RAC-O-HB mix is still performing.
- Surface distress from the underlying concrete is reflecting through the RAC-O-HB mix.
- Where RAC-O-HB mix and conventional HMA were placed adjacent to each other, the RAC-O-HB mix has performed much better than the conventional HMA mix.

- Lessons learned from this project need to be clearly communicated and not repeated. This included properly preparing the underlying pavement prior to placing any overlay treatment.
- When the RAC-O-HB mix is considered for a project, a correct mix design and proper construction sequences must be developed.
- Specifications for RAC-O-HB mixes need to be strictly enforced.
- Although RAC-O-HB mixes have been used successfully on several Caltrans projects, they may not be appropriate for all applications because of project location and temperature requirement constraints.

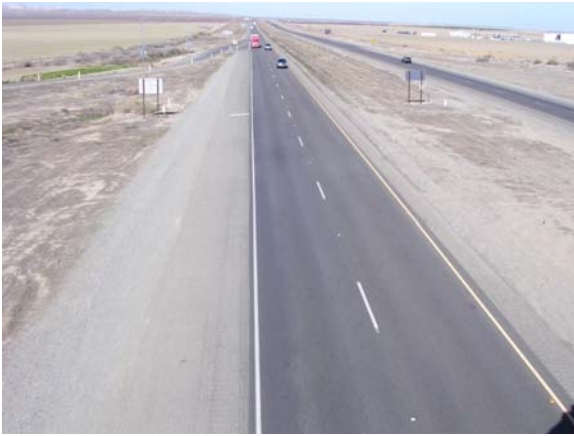
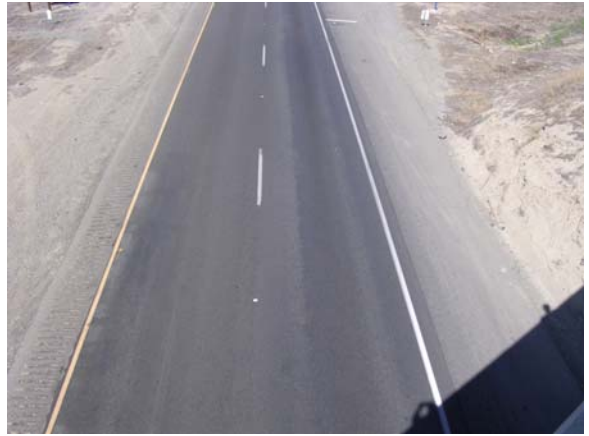
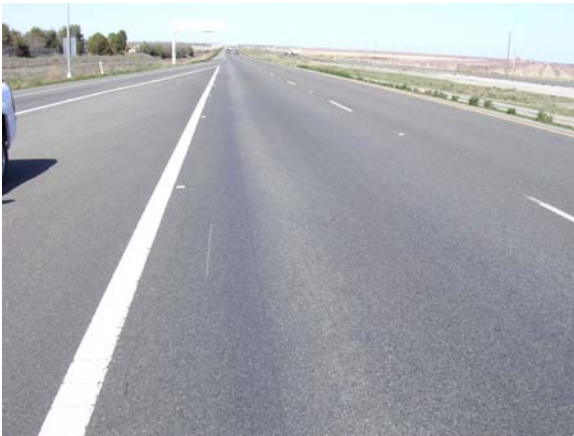
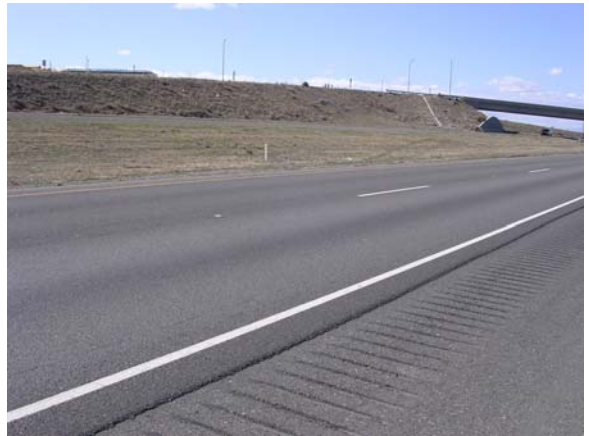
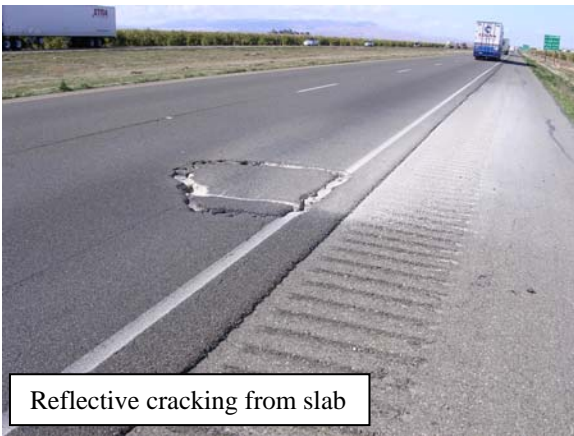
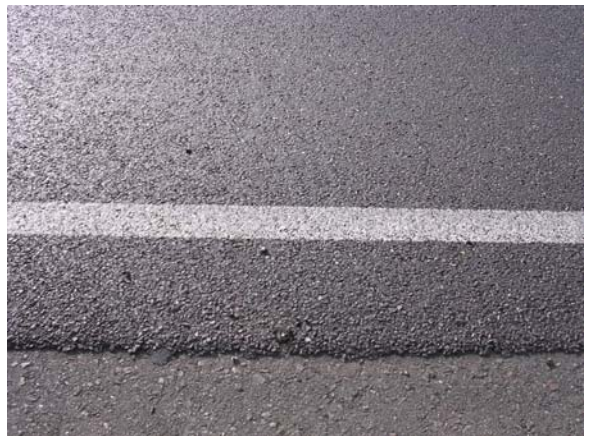
### Selected Photos from the Fresno I-5 Project (March 1, 2007)

Several other projects have been constructed with RAC-O-HB mixes in California and have performed extremely well. A summary of the projects is given in Table 4-1 below. Selected photos from the FRE 5 project listed below are included in Appendix B.
