Performance of Rubberized Asphalt Concrete Open Graded High Binder Content (RAC-O-HB) Surface Mixes in California

Report Number: CP2C- 2007 - 105

PROJECT SUMMARY PAGE	Technical Report: CP2-105-2007
Title: Performance of Rubberized Asphalt Concrete Open Graded High Binder Content (RAC-O-HB) Surface Mixes in California	
Author: Stroup-Gardiner, M., and Hicks, R.G.	
Prepared for: California Department of Transportation Office of Pavement Preservation Division of Maintenance 5900 Folsom Blvd	Client Reference No.:
Prepared by: California Pavement Preservation Center California State University, Chico Chico, CA 95929-0930 October 10, 2007	Date: Oct. 15, 2007
Abstract: The California Department of Transportation constructed six experimental sections using a rubberized asphalt concrete open graded with a high binder content (RAC-O-HB) as the surface layer. This was placed over two types of Portland cement concrete (PCC) and four hot mix asphalt (HMA) existing pavement structures. The PCC projects received either partial traditional concrete repairs or cracking and seating prior to placement of the RAC-O-HB. The existing HMA surfaces were resurfaced without repair. Traffic levels ranged f

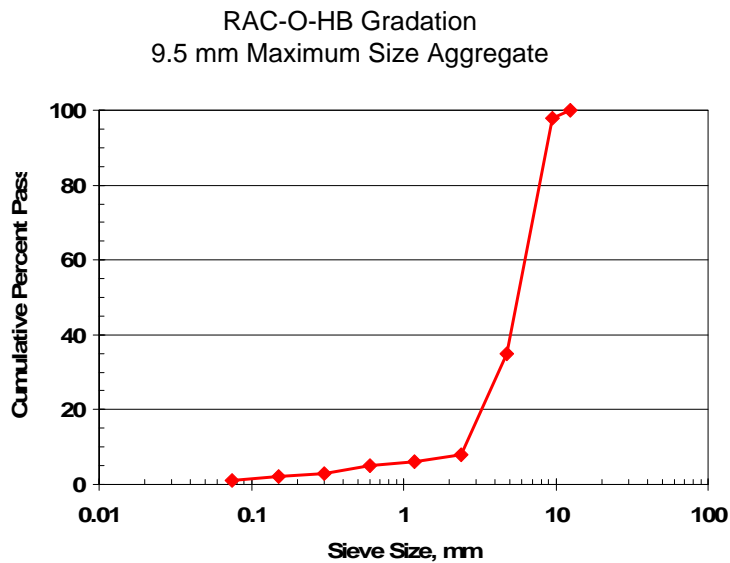
Figure 2. Typical aggregate gradation for RAC-O-HB (after Way 2007).

Table 1 shows a typical set of aggregate properties for the RAC-O-HB mixes used for in these case studies. The aggregates are high quality with low LA abrasion values, high specific gravities (implying low water absorption capacities), and 100% crushed (Caltrans 2003; Way 2006 and 2007). The gradation is predominately 2-sized, with 63% of the 4.75 mm size and 27% of a 2.36 mm size (Figure 2).

The 100% crushed faces requirement for all of the aggregates used in these mixes provides the high quality, wear resistant, angular shape needed for skid resistance and aggregate interlock for shear (rutting) resistance

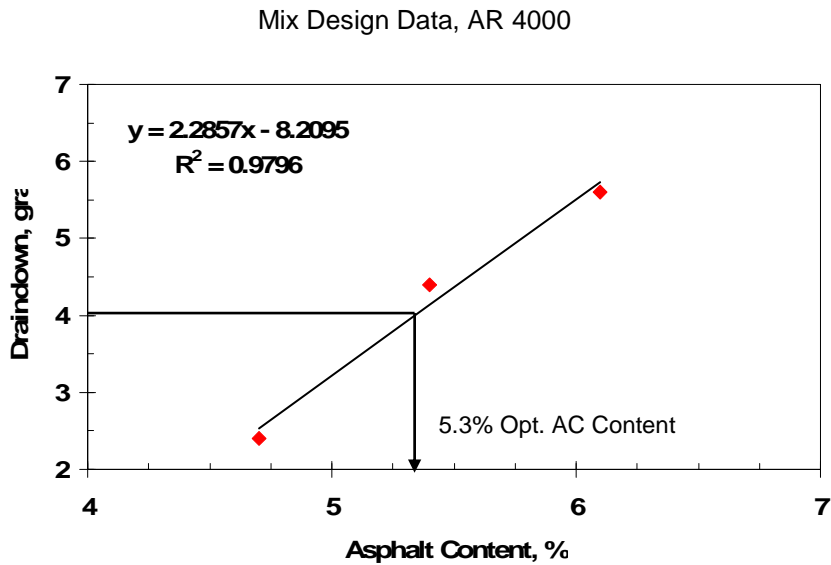
Figure 3. Selecting optimum binder content for open graded mix (K_c is 1.4).

The basis for the Caltrans RAC-O-HB mix design is the California Test 368 Standard Method for Determining Optimum Bitumen Content for Open Graded Asphalt Concrete (Caltrans 2007-1). This test method statically compacted discs of asphalt-coated aggregate, then uses a draindown test to select the highest binder content with a draindown of no more than 4 grams. The approximate binder ratio (ABR) is used to estimate the binder content used for preparing samples. The ABR is calculated as the centrifuge kerosene equivalent (K_c) times 1.5 plus 4.0. The K_c value, which was 1.4 for these projects, is determined according to the California Test 303 Standard test for Centrifuge Kerosene Equivalent and Approximate Bitumen Ratio (Caltrans 2007-2). Figure 1 shows how the optimum binder content is determined for open graded mixes using a conventional paving grade binder. The optimum rubberized binder content for open graded mixes is then defined as the optimum content times 1.2 (i.e., a 20% increase for rubberized binders). Based on other state's experiences and recommendations from industry, Caltrans selected the optimum binder for the high binder content RAC-O-HB mixes as 1.65 times the optimum binder content for open graded mixes using conventional AR4000 paving grade binder. Industry also recommended that this value be set at a minimum of 8.5%. It is important to note that California describes the optimum binder content as a percent of the dry weight of aggregate rather than the total weight of mix.

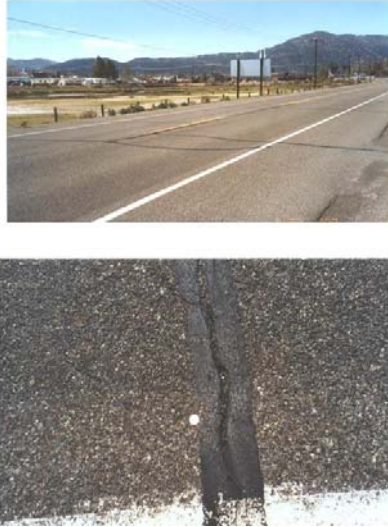
Figure 6. Typical condition of Mono 395 after 7 years.

Transverse cracking consistently observed at spacing of between 25 and 50 feet. This type of cracking distress is environmentally related and is due to either long term thermal cycling or large single drops in temperature. It is likely that the cracking in the RAC-O-HB is a reflection of cracking patterns in the old HMA surface. Some of the transverse cracks had been sealed to limit water intrusion into the underlying layers (Figure 6).

Alligator cracking, a traffic load-related distress, is only seen in limited areas of the project. These limited areas also exhibited some loss of material (raveling). Rutting was usually less than 1/8 in; in some cases rutting was as much as 3/8 inch.

The reviewers noted that the ride was good, with some occasional noticeable bumps at the transverse cracks. The PCI for this project was estimated between 74 and 88. In general, this RAC-O-HB is in good shape for a 7 year old surface treatment.

**Mono 395 PM 76 – 84.5
RAC-O-HB Over Distressed HMA
Estimated 297,000 Annual ESAL's**

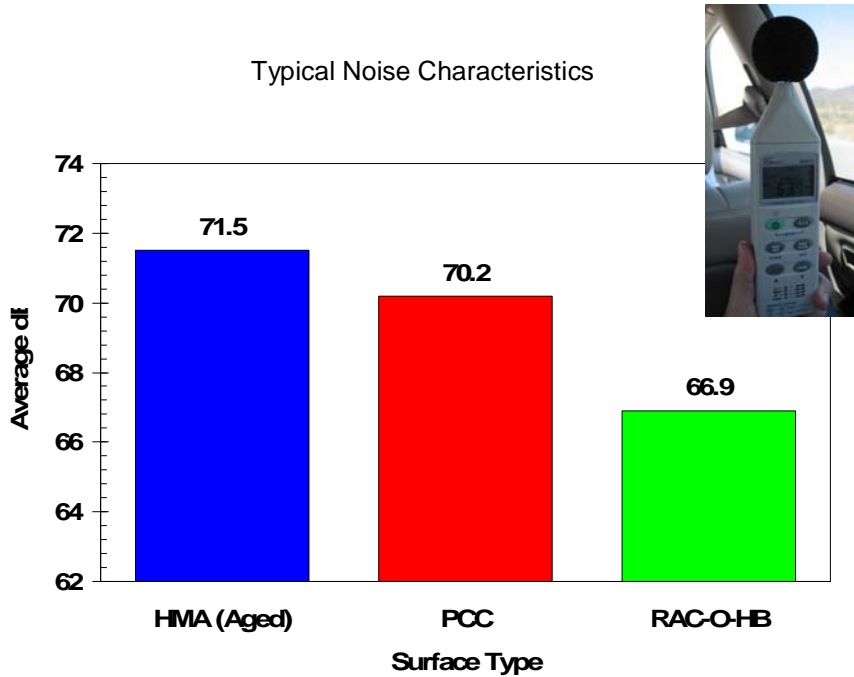
Figure 9. Estimates of noise levels inside car on various surfaces (photo from Way 2007).

The noise testing for the RAC-O-HB projects was conducted with a hand held noise measurement device from inside of a Lexus, with the windows closed and the air conditioner on low. This type of testing can be considered a variation of the close proximity (CPX) type of testing with the acoustical chamber being the interior of the car. This provides a relative comparison of occupant-perceived sound levels as the car travels over different pavement surfaces.

The noise levels for the projects are shown in Table 3. Nearby pavements with old HMA and Portland cement concrete surfaces were also tested when possible. The average dB level of the old HMA and the PCC surfaces tested were similar (71.5 and 70.2 dB, respectively) and 66.9 dB after 5 to 7 years of service for the RAC-O-HB (Figure 10). Because the dB scale is a logarithmic scale, a 3 dB reduction in the noise level is considered significant. For these projects, the RAC-O-HB treatment produces pavement surfaces with almost 5 dB reduction in noise compared to conventional HMA. The level of noise reduction achieved with the RAC-O-HB mixes is consistent with previously reported values.
