**Los Angeles County Department of Public Works Asphalt
Rubber Chip Seal with Warm Mix Additive Demonstration
Project**

Report Number: CP2C-2010-107

September 16, 2010

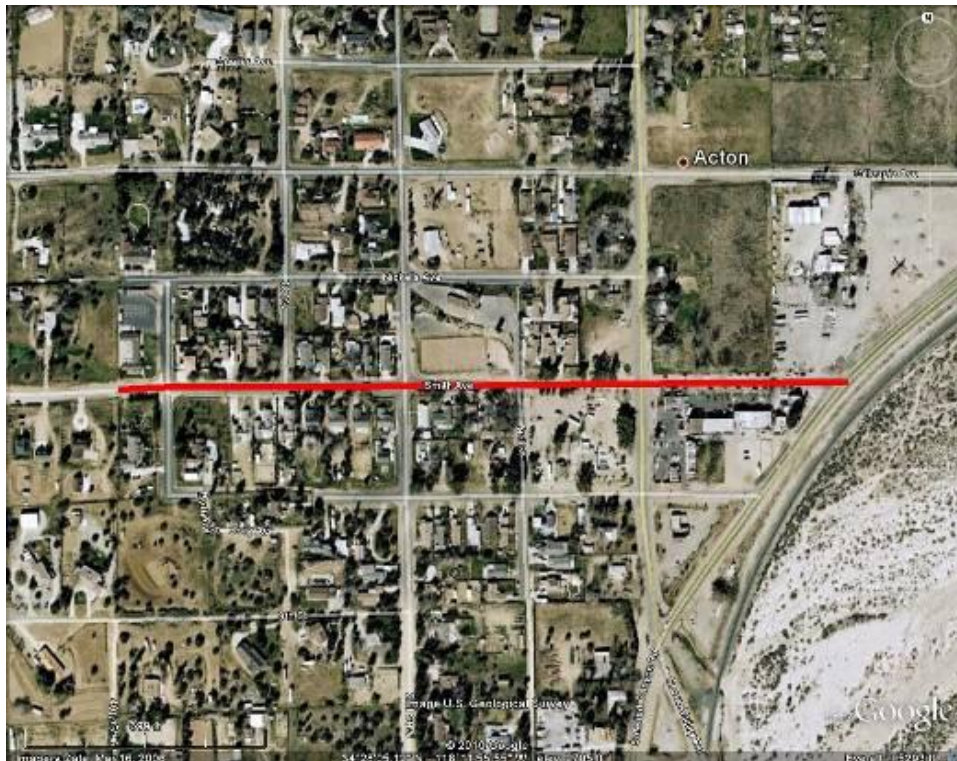
Figure 1 Aerial photograph and project location

The project was performed on Smith Avenue, a two lane residential street oriented East-West in the unincorporated community of Acton, California. The project location, highlighted in red, is shown in Figure 1. The project limits are Soledad Canyon Road to the East and the end of the County maintained road to the West, approximately 300 feet past Bartlett Street.

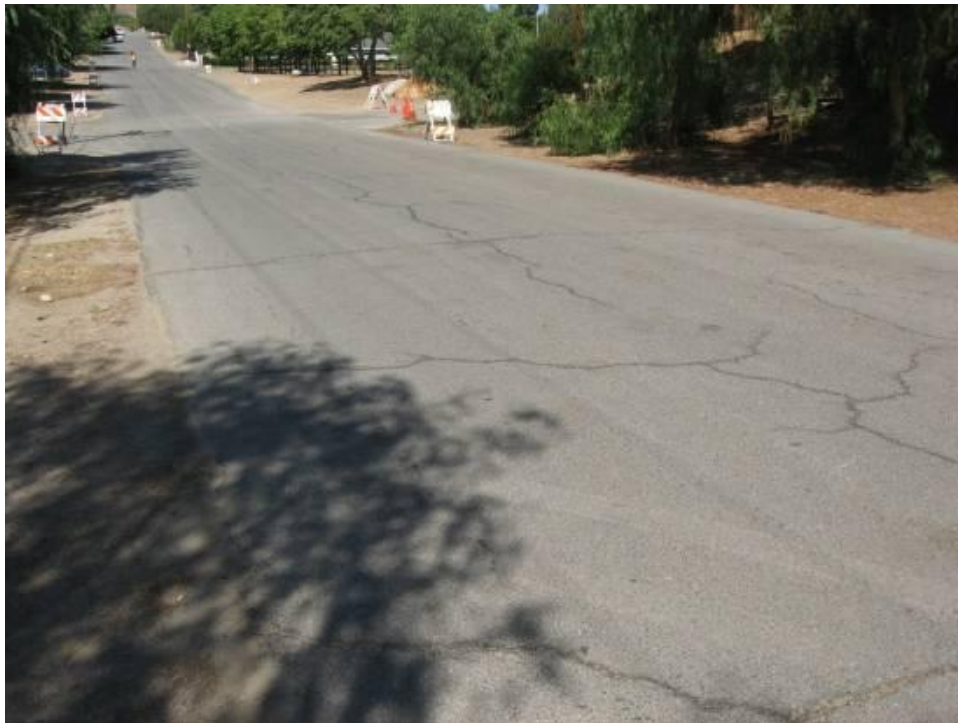
Smith Avenue is an asphalt concrete surfaced pavement showing high severity longitudinal and transverse cracking throughout the entire project. Longitudinal cracking is not necessarily located in the wheel paths, an indication that the distress is not load-associated. Transverse cracking was found, on average, every 15 to 20 feet. Both longitudinal and transverse cracks were about one inch wide and the sides of the cracks were slightly raised. Traces of crack sealant were observed along few of the wider cracks. No significant rutting was observed. Few large patches were noticed throughout the entire project. A snapshot of the typical distresses found is shown in Figure 2.

Figure 2 Longitudinal and transverse cracking on Smith Avenue

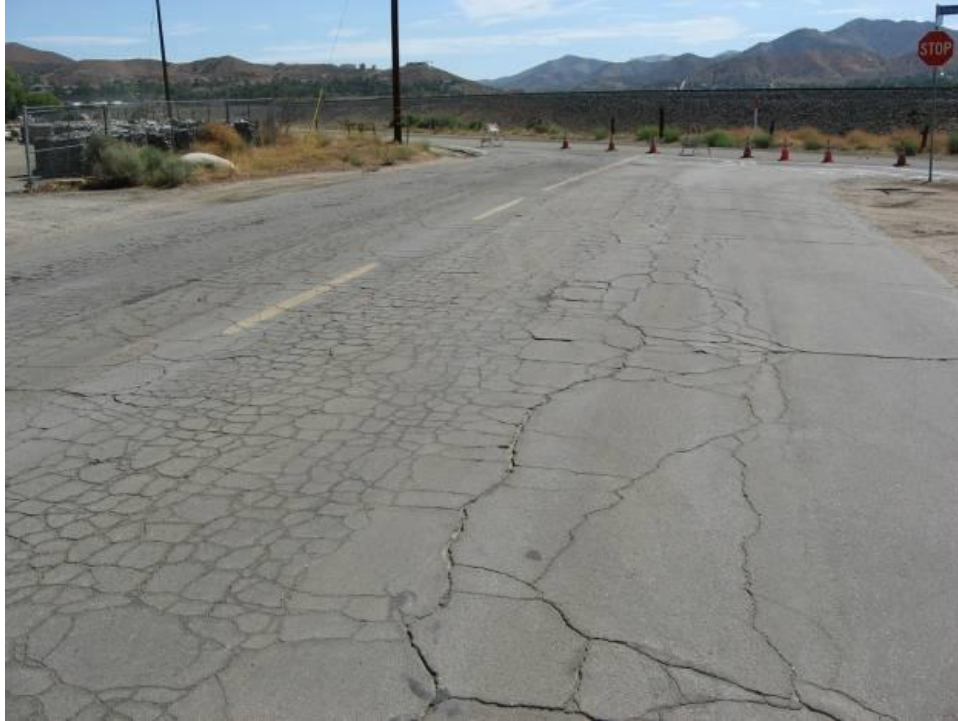
The portion of Smith Avenue from Soledad Canyon Road to Crown Valley Road had considerably more distress, with more frequent transverse cracks and several areas of high severity alligator cracking, as illustrated in Figure 3. Due to its location between two collectors (Soledad Canyon Road and Crown Valley Road) this segment of Smith Avenue is probably subject to more frequent and heavier traffic. The alligator cracking occurred only in certain areas of the pavement.

Figure 3 High severity alligator cracking on Smith Avenue before Soledad Canyon Road

The pavement appears to be a thin 1 to 1.5 inch asphalt concrete surface over sandy subgrade, probably the natural surficial soil in Acton. While the application of the cape seal will result in a temporary improvement in appearance, the treatment will not significantly affect the structural capacity of the pavement and reflective cracking should be expected. No cores were taken and no deflection testing was performed on the project prior to construction.

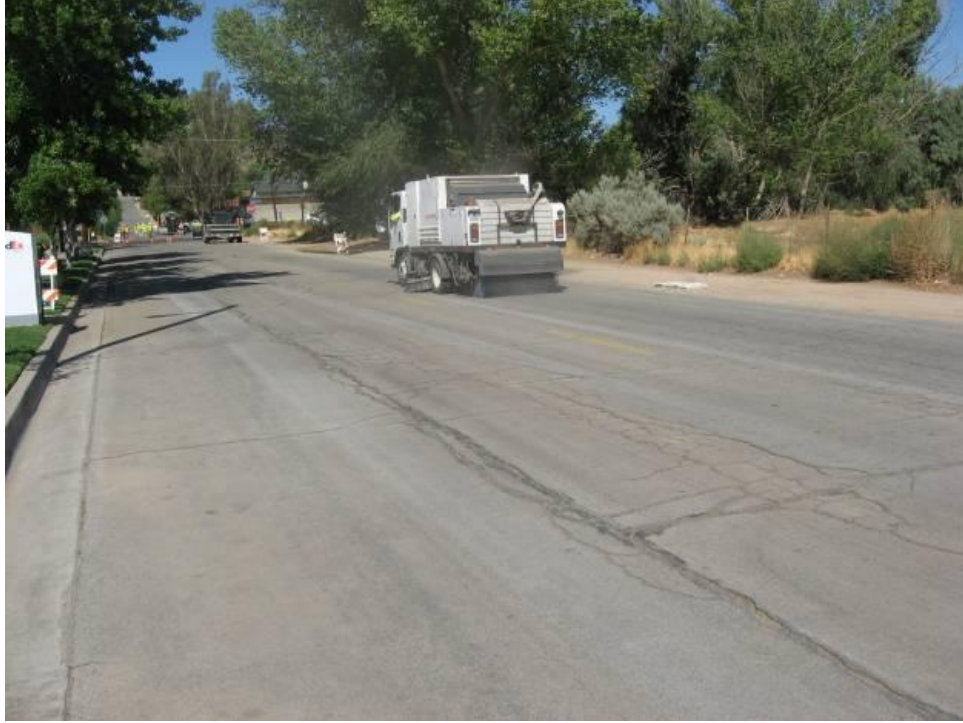
Preparation for laydown operations started around 10:00 AM. The entire pavement surface was initially swept as illustrated in Figure 4. The chip seal was then placed on the westbound lane of Smith Avenue starting from Crown Valley Road and going West, in four segments. The binder was placed first, using a binder distributor with a spray bar. A tarp was used before each start as illustrated in Figure 5.

Figure 4 Sweeping the existing surface before laydown of AR chip seal

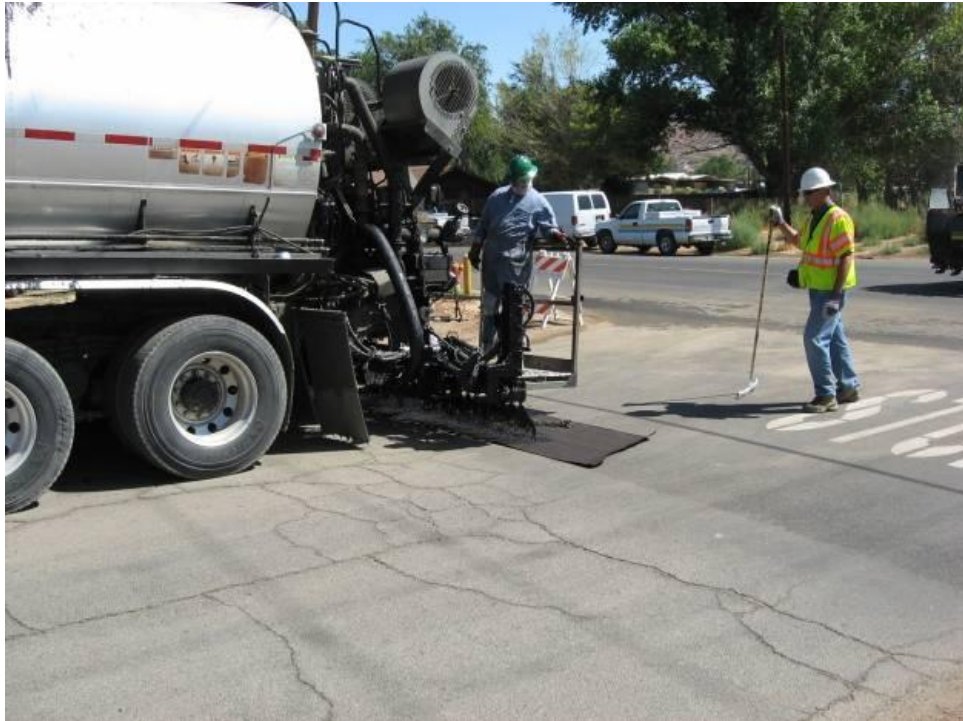
Figure 5 Tarp being used under the spray bar at the beginning of a new section

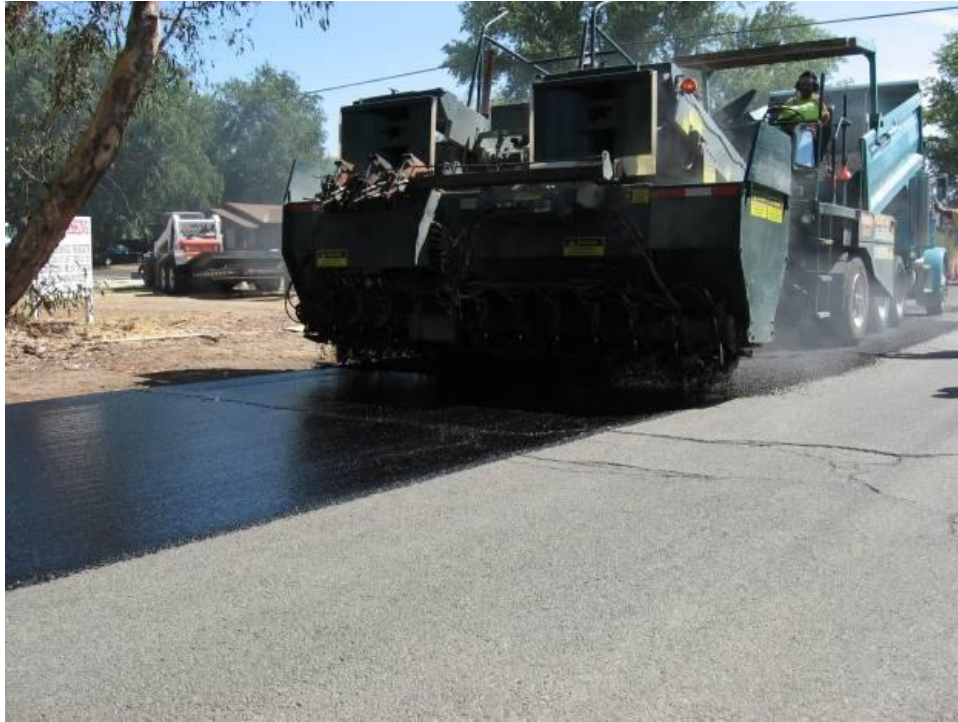
The pre-coated chips were placed shortly after the binder with a chip spreader, as illustrated in Figure 6. Aggregate was supplied to the spreader from a haul truck. Two pneumatic rollers were used for compaction as shown in Figure 7.

Figure 6 Chips placed on the asphalt rubber binder with warm mix additive

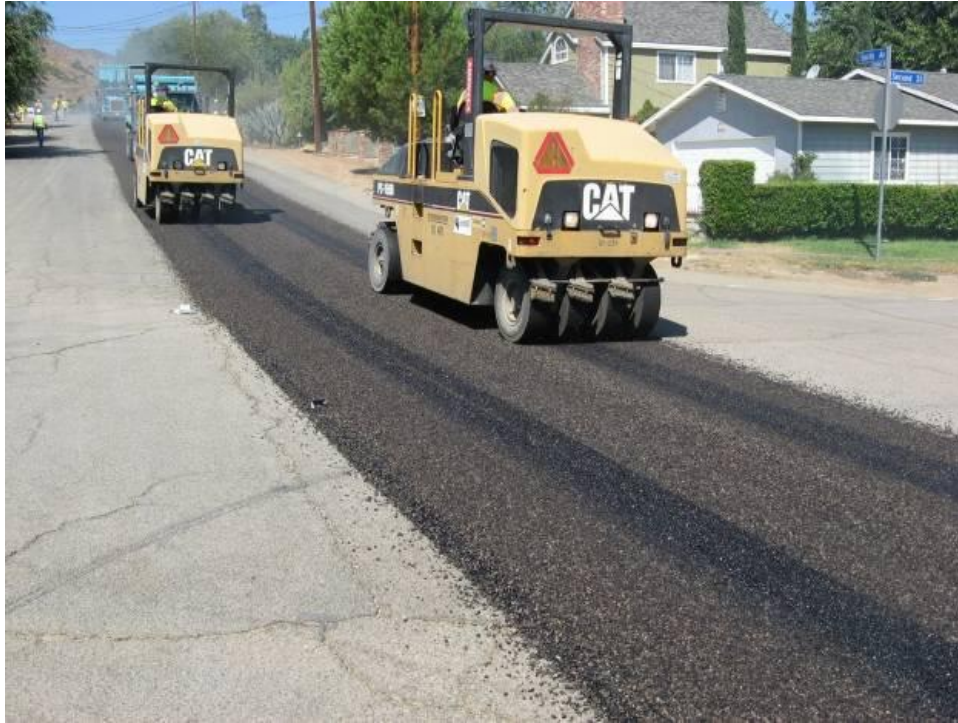
Figure 7 Compaction

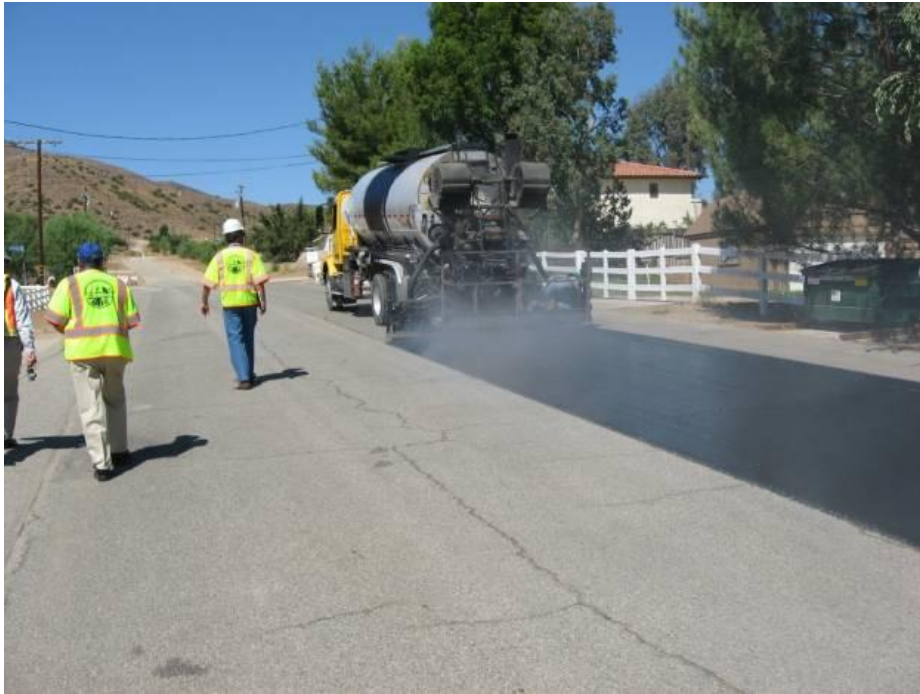
LADPW representatives were especially interested to see whether the use of the warm mix additive will result in reduced emissions during construction. Indeed, fumes were visibly less than what would be

expected from a conventional asphalt rubber chip seal project. This is further illustrated in Figures 8 and 9.

Figure 8 Visible emissions during binder application

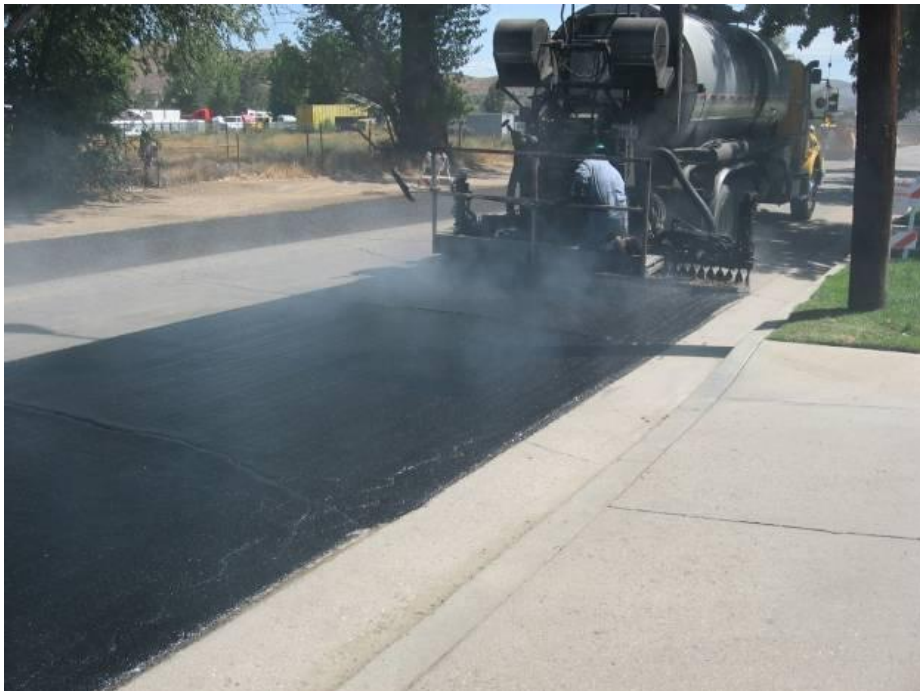
Figure 4 Emissions during binder application

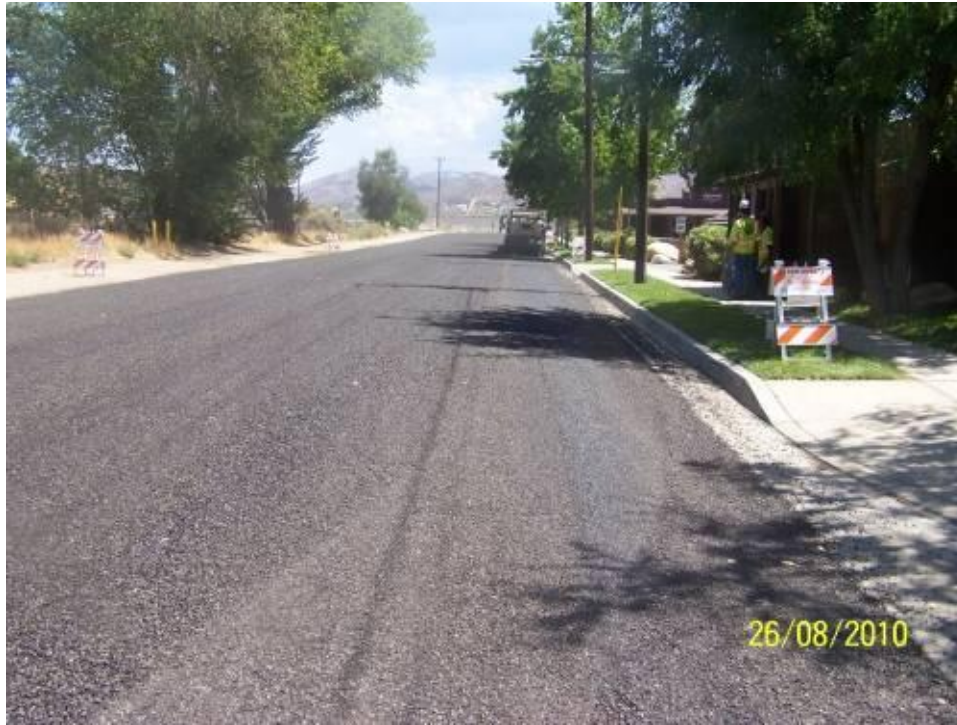
The finished chip seal is shown in Figure 10.

Figure 50 Finished chip seal

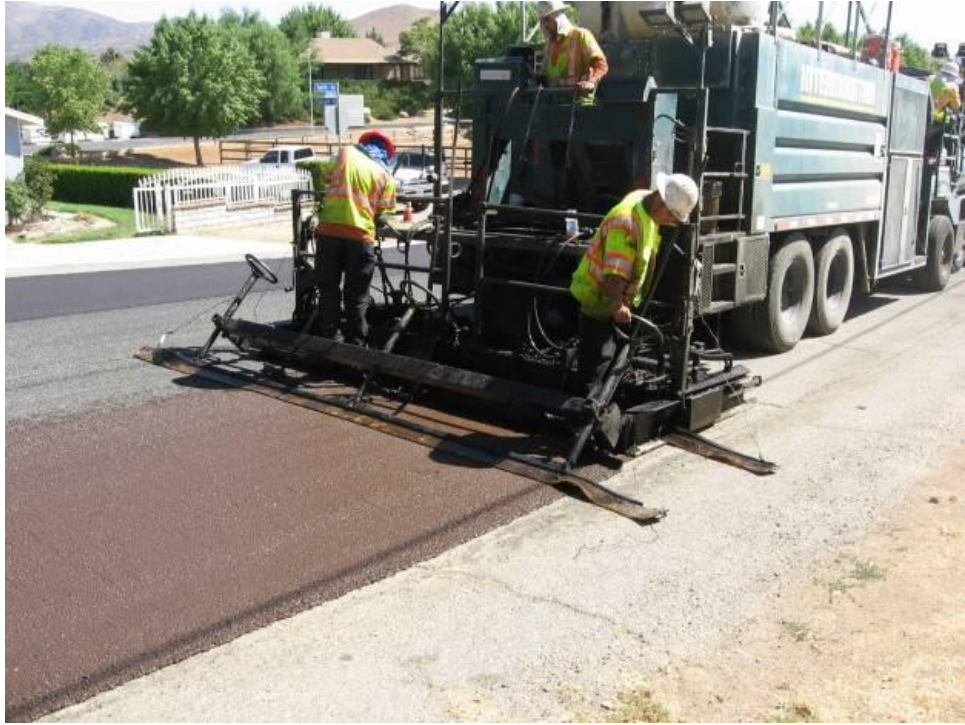
One week after construction, a Type II micro-surfacing was placed over the chip seal. This combination of chip seal and microsurfacing is also known as cape seal. Placing of the micro-surfacing is illustrated in Figure 11. The finished cape seal can be seen in Figure 12. The brownish color on the left side of Figure 12 indicates that water was still present in the microsurfacing at the time the photograph was taken.

Figure 6 Microsurfacing applied over chip seal

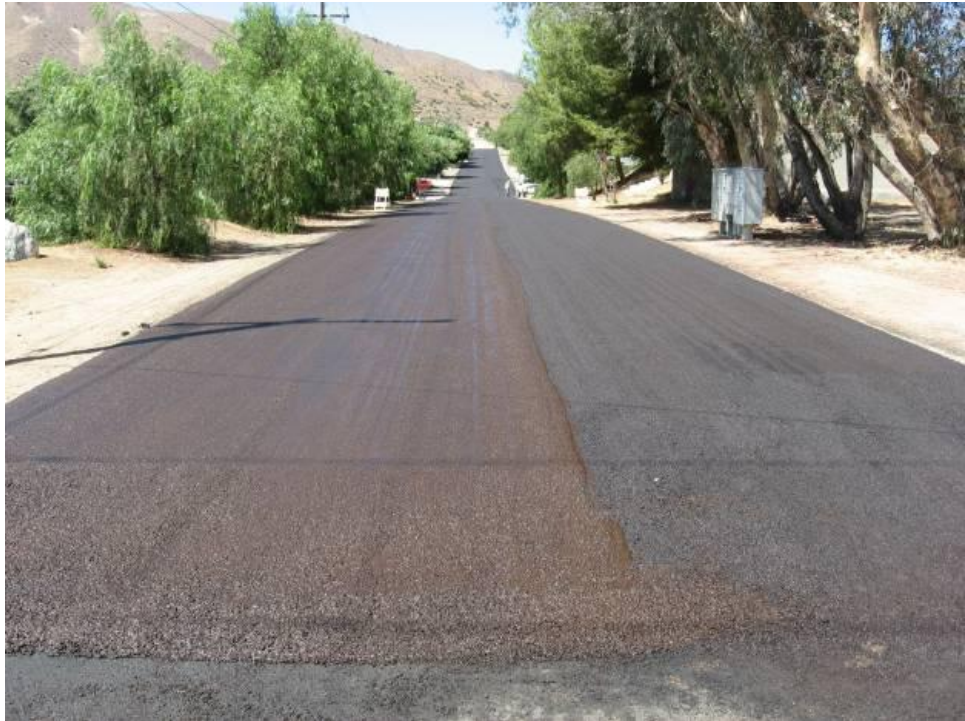
Figure 7 Finished cape seal on Smith Avenue

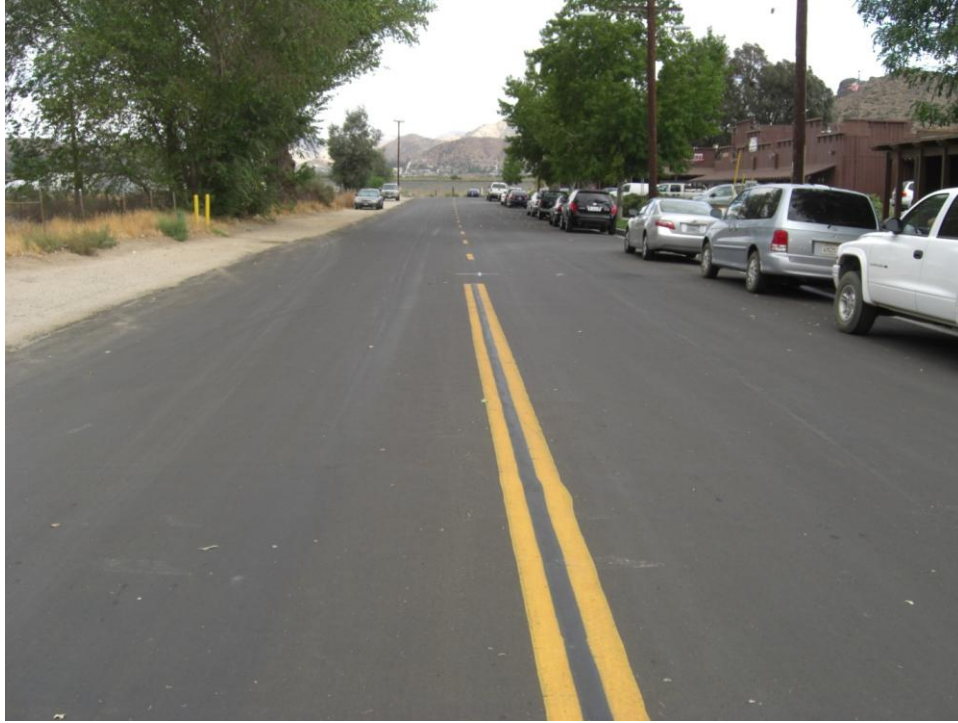
A photograph of Smith Avenue after striping and opening to traffic is shown in Figure 13.

Figure 13 Smith Avenue after striping
