California's Perspective on Concrete Pavement Preservation

ABSTRACT

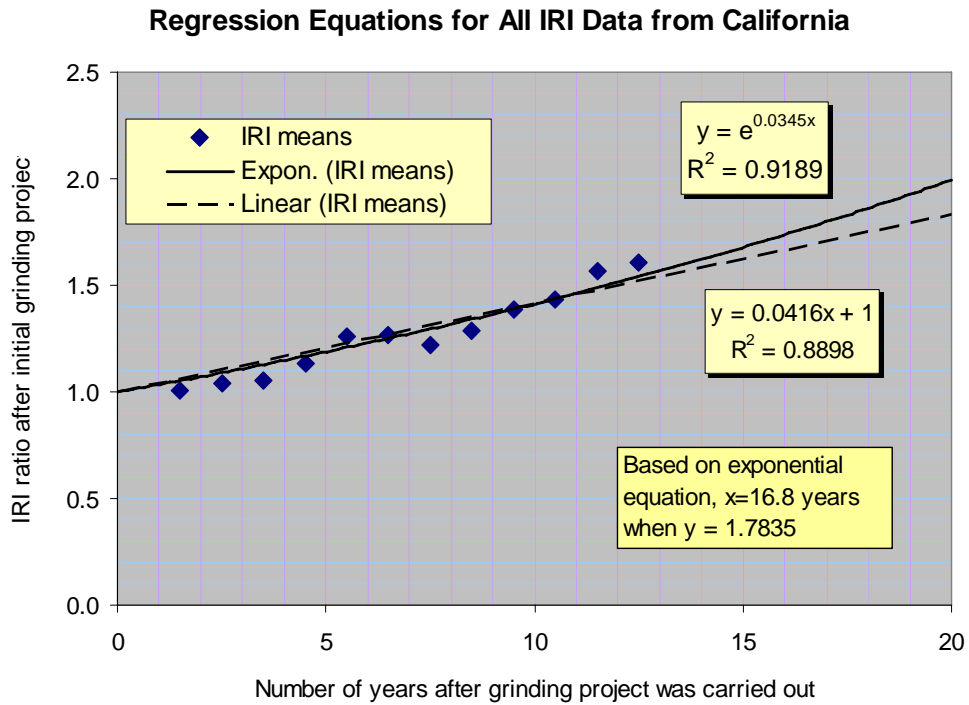
Figure 1 shows the average decrease in IRI after diamond grinding based on 29 statewide projects within California. Figure 2 shows the various confidence levels associated with the statistics for these same 29 projects. Two forms of regression equations were fit to these data. While both provide good R^2 values, the exponential fit (Figure 1 and Figure 2) is recommended for use since it is unlikely that the progression of IRI will remain constant from cradle to grave, as the linear regression equations would imply.

Figure 1. Change in the ratio of IRI over time as a function of the initial IRI after grinding (2).

A study carried out by Caltrans (2) found that the average roughness in terms of IRI before a planned PCC grinding project by Caltrans was 165 in/mi (2.61 m/km) before grinding and 93 in/mi (1.46 m/km) after grinding. Thus the average before / after IRI grinding ratio in California is $165.3 / 92.7 = 1.78$. Moreover, this level of improvement (limited to California—mostly frost-free) results in an average treatment life of nearly 17 years before further rehabilitation or preservation (e.g., another grinding project, if feasible) is needed. These figures compare favorably with the reported national average longevity of a given grinding project of approximately 14 years (3). Moreover, since diamond grinding is almost always carried out on structurally sound (albeit having poor ride quality) concrete pavements in California in a timely manner, it is possible that the life extension of the pavement could be nearly as long as the treatment life itself.

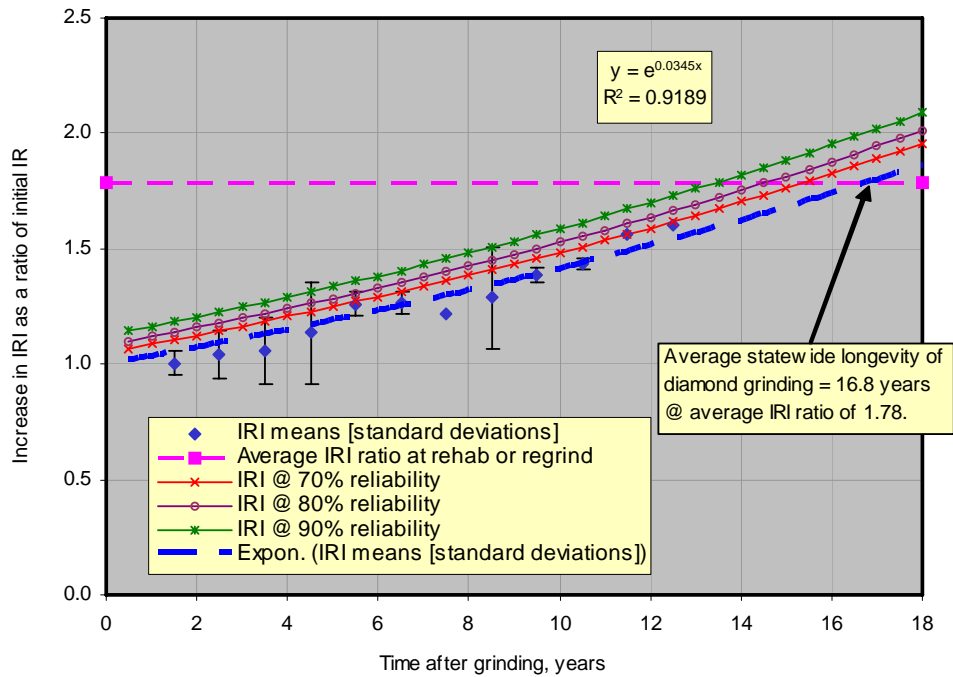
Figure 2. Reliability levels for the expected survivability of California diamond-grinding projects (2).

For planning and design purposes, furthermore, it is recommended that the selected treatment life reliability level should be around 80 percent, which translates to about 14.5 years (see Figure 2)—perhaps slightly more for low- to medium-volume traffic roadways or slightly less for high-volume traffic roadways.

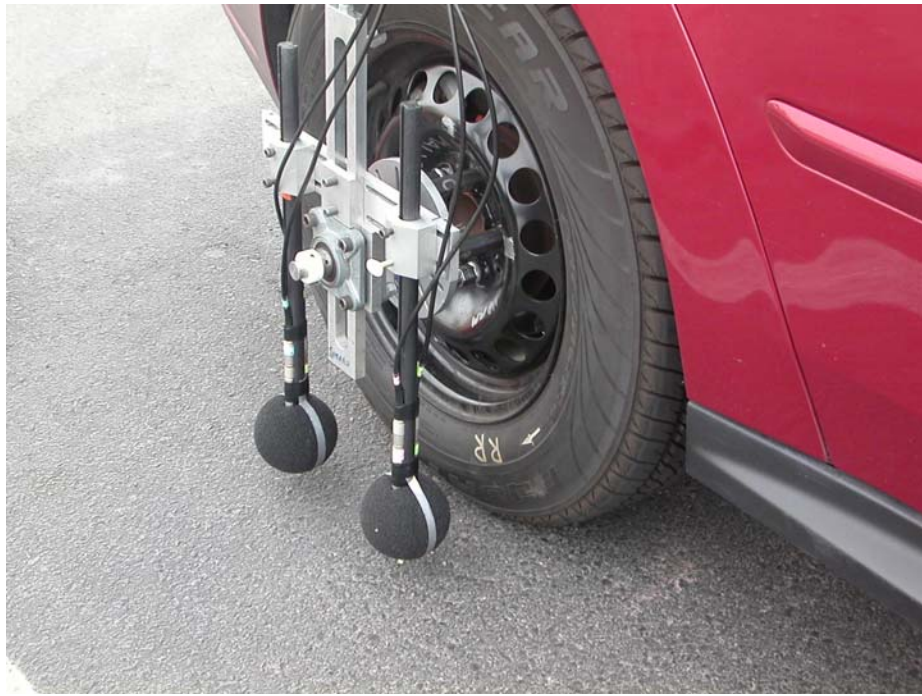
A measuring technique has been developed to accurately measure tire-pavement noise levels, called on-board sound intensity or OBSI. A typical setup using dual microphones to measure OBSI pavement–tire interface noise level is shown in Figure 3.

Figure 3. OBSI microphone setup—two-probe system.

Currently, there is no Standard Test Method for measuring OBSI. However, methods are currently under development at both ASTM and AASHTO using the two-microphone setup shown in Figure 3.

Note that OBSI levels are measured only some 5 in. (127 mm) from the source of the noise, i.e., from the tire–pavement interface as shown in Figure 3, and are thus wildly exaggerated compared to what a person would hear inside a typical vehicle or in the proximity of a high-speed roadway. Accordingly, the OBSI values shown in Table 2 should be used for comparative purposes only, not to ascertain the true dBA level heard by the traveling (or nearby) public. The main point to be made is that diamond grinding significantly reduces noise levels resulting from high-speed concrete roads, such as freeways and tollways.

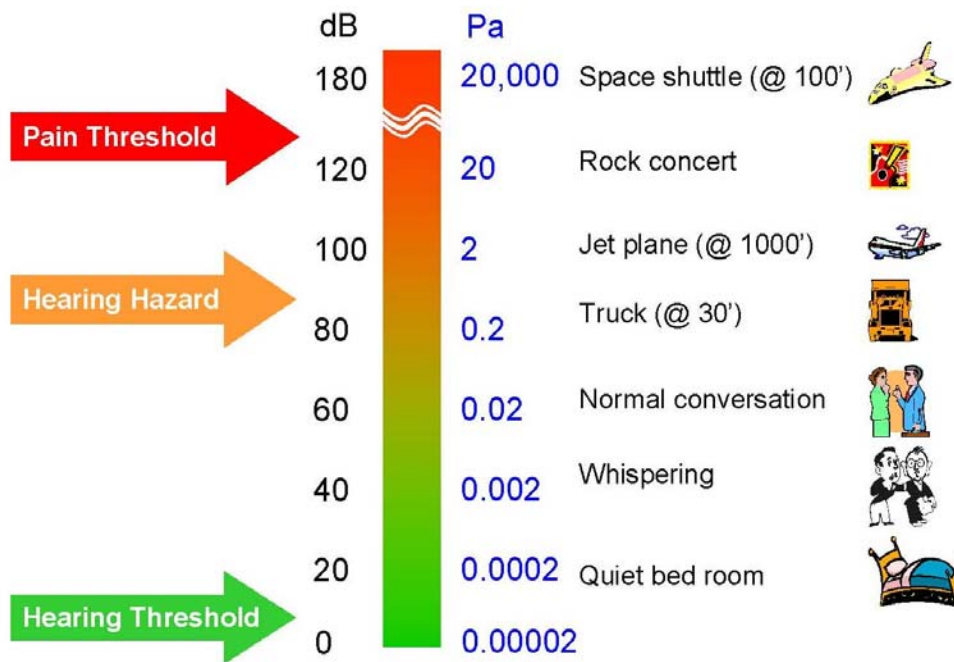
Typically, decibels (dB) are stated in terms of a weighted average value, called dB(A) or dBA, which covers the so-called *A-weighted* range of audible frequencies to the human ear. Audible sources of typical noise using two methods of measuring sound levels are shown in Figure 4.

Figure 4. Conversion from sound pressure to perceptible noise levels and typical examples of dB(A) levels at normal distances from various sound sources (6).

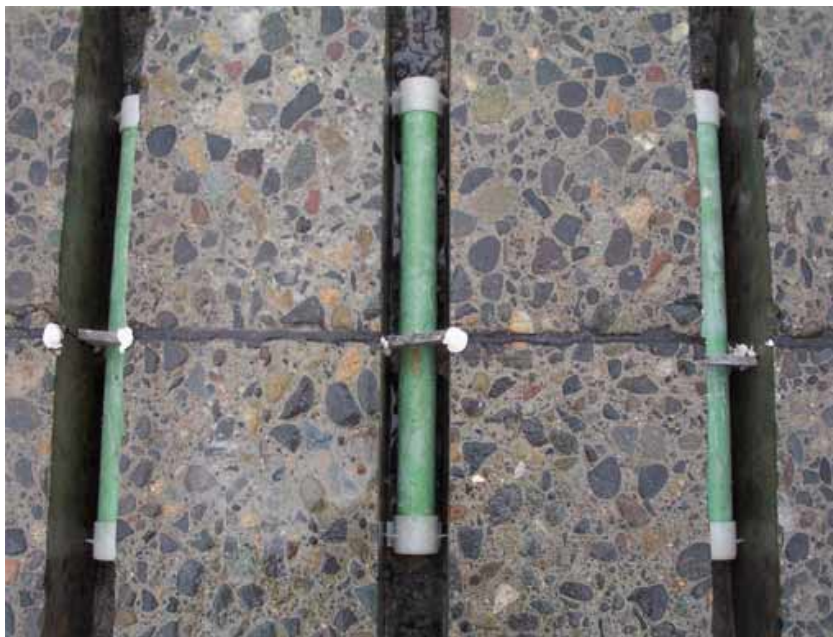
Poor load transfer across transverse joints was listed above as one of the factors that should preclude the use of diamond grinding. Dowel bar retrofit (DBR) rectifies poor load transfer and can be used in combination with diamond grinding. DBR (see Figure 5)—if properly carried out—can be a very effective pavement preservation strategy. This approach can be used to remedy poor joint load transfer, thus rendering a diamond grinding project feasible—barring any other precluding conditions in the above list.

Figure 5. Dowel bar retrofits at a transverse joint (8).

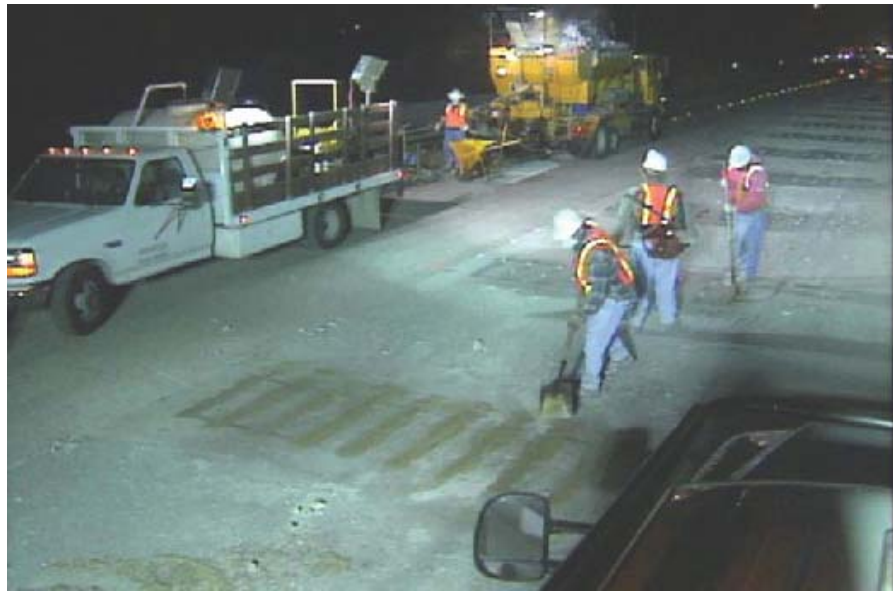
This strategy can be very successful when properly designed and constructed. For example, an extensive project in 1999 along the I-10 freeway in Los Angeles County, California, proved to be a very successful DBR project prior to grinding (see Figure 6). Excellent materials and workmanship, together with an adequate time window before opening to traffic, were achieved throughout the project. By 2008, a mere 2 percent of the 22,000 dowel bars (11 per joint) have shown some signs of distress—some 9 years after the fact. Many other successful DBR projects have also been constructed in California since the early 2000s.

Figure 6. Successful dowel bar retrofit project on I-10 in Pomona, CA (9).

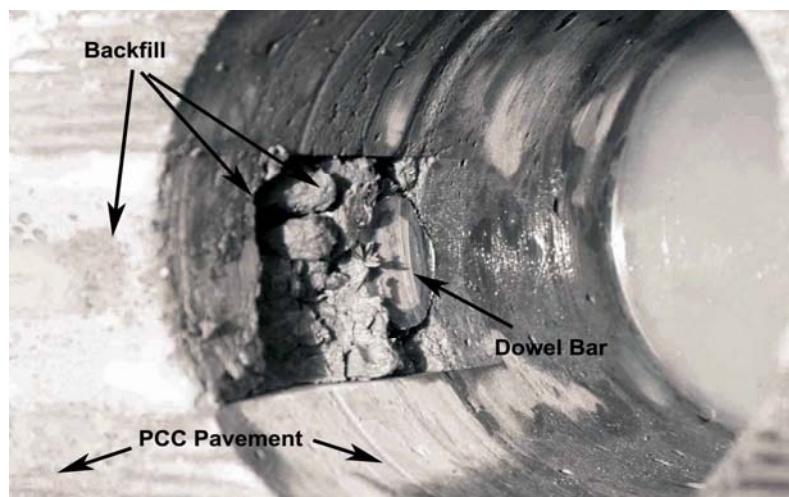
On the other hand, there have been reports of dowel bar retrofit distresses in some projects in California. These distresses appear to be related to materials or workmanship in the rather demanding process of dowel bar retrofitting. An example of one of these distressed projects is on I-5 in Orange County. In this project, it appeared that the grouting material was not properly consolidated (vibrated) between the edge of the slot and the dowel bar (see Figure 7), and there were many locations of misaligned dowels.

Figure 7. A poorly performing dowel bar retrofit on I-5 in Orange County (10).

In other instances of premature failure, it has been found that the dowel bar slots were not thoroughly cleaned prior to placing the backfill material, thus resulting in an inadequate bond between the backfill and the original concrete. There were instances where the dowels were misaligned because inexperienced contractors did not use gang-saws and had a hard time retaining the correct dowel bar alignment.

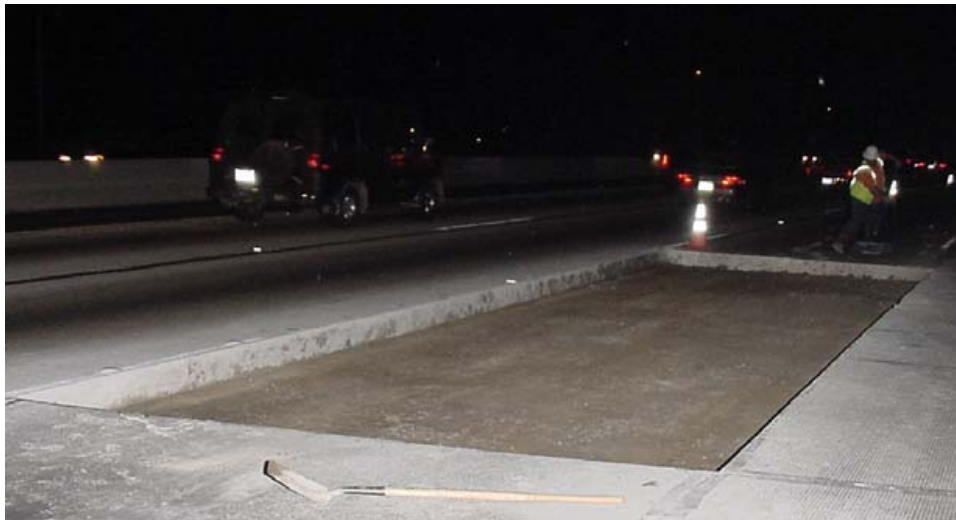
Full-depth slab repairs, or replacements, are used when isolated slab distresses are too severe to warrant other forms of pavement maintenance and preservation. Full-depth repairs may be used with or without followup diamond grinding, depending on the overall pavement condition and the remaining life expectancy of the untreated pavement. A typical photo of a removed slab prior to a slab replacement panel is shown in Figure 8.

Full depth slab repair involves full-depth and -width slab removal followed by cast-in-place replacement of slabs (or partial-length slabs) in an existing pavement. Typically the minimum length requirement is 6 ft (1.8 m); however, when repair areas are closely located it may be more cost effective to substitute a larger area—usually the full length of the original slab. Guidelines associated with full-depth slab repairs, such as reestablishing joints, etc., are detailed in the Caltrans *Slab Replacement Guidelines* document (11).

Figure 8. A full-depth concrete slab replacement project (11).

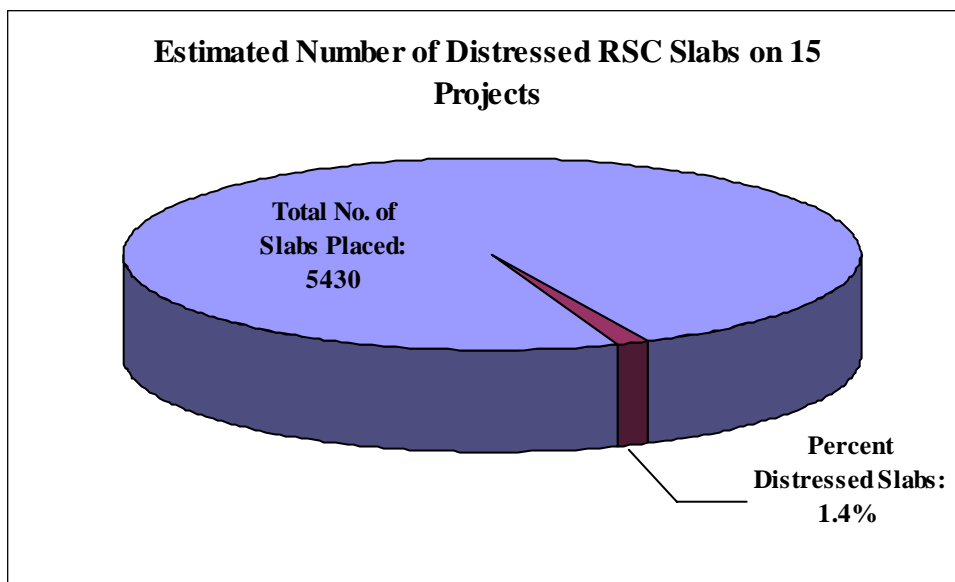
RSC cement mixtures have performed very well in California, indicating both excellent concrete design and construction practices (13). A total of 15 statewide projects were surveyed by Caltrans recently for premature distresses on RSC slab replacements. The results were excellent (see Figure 9), with less than 2 percent of the surveyed slabs showing any significant surface distresses. Where distresses were observed, shrinkage cracks were the most prevalent distress type.

Figure 9. Percent distressed slabs on surveyed RSC projects (13).
