## Use of Vitreous-Ceramic Coatings on Reinforcing Steel for Pavements

### ABSTRACT

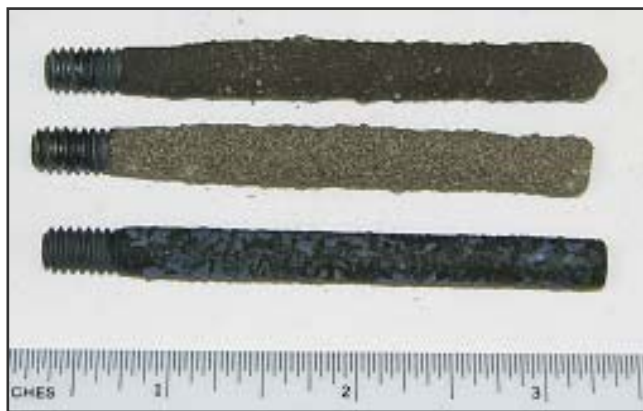
**Figure 1. Examples of test rods prepared with various samples of glass frits with an outer coating of portland cement applied to the melted glass.**

The porcelain enamel coating was fired onto steel at temperatures from 745 to 850 °C. Firing times were typically from 2 to 10 minutes, depending on the mass of metal to be heated and the size of the furnace. No attempt was made to obtain an even or smooth coating as would normally be the case for porcelain enamels for appliances, bathtubs, etc. (Figure 1). The enamel coatings had an average thickness of 0.8 mm.

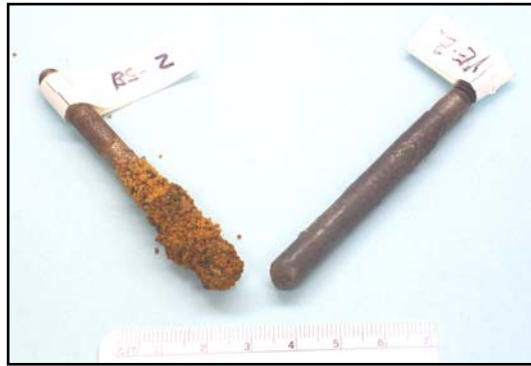
**Figure 4. Corrosion on bare steel surface (left) and on enameled steel after 40 days of exposure in salt-water saturated sand. The corrosion of the bare steel cemented sand to the rod.**

Examples of the effect on a bare steel rod and an enamelled rod after 40 days exposure is shown in figures 4 and 5. Active corrosion was noted where steel was exposed to the salt-water saturated sand (left), and the build-up of iron oxide cemented the adjacent quartz sand to the surfaces of the bare steel rods (Figure 4). Enamel rods both with and without the portland cement addition showed no active corrosion where the enamel was present to protect the steel. Enamel does not debond, and studies with intentionally created defects that exposed the surface of the steel resulted in only local limited occurrence of corrosion. Figure 6 shows an optical photomicrograph of a polished section through an enamelled test rod that had been drilled to remove the enamel. Note that the enamel does not delaminate or allow capillary transfer of fluids under the enamel.

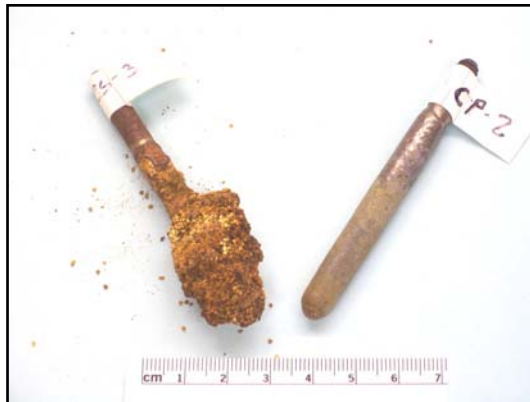
**Figure 6. Exhibition of evident corrosion of bare steel surface (left) and not evident on enameled steel containing portland cement after 40 days of exposure in salt-water saturated sand. The corrosion of the bare steel cemented sand to the rod. A powdery, alkaline deposit formed from the hydration of the exposed portland cement.**
