# **Retrofit Dowel Bars in Jointed Concrete Pavement— Long-Term Performance and Best Practices**

Thomas Burnham<sup>1</sup> and Bernard Izevbekhai<sup>2</sup>

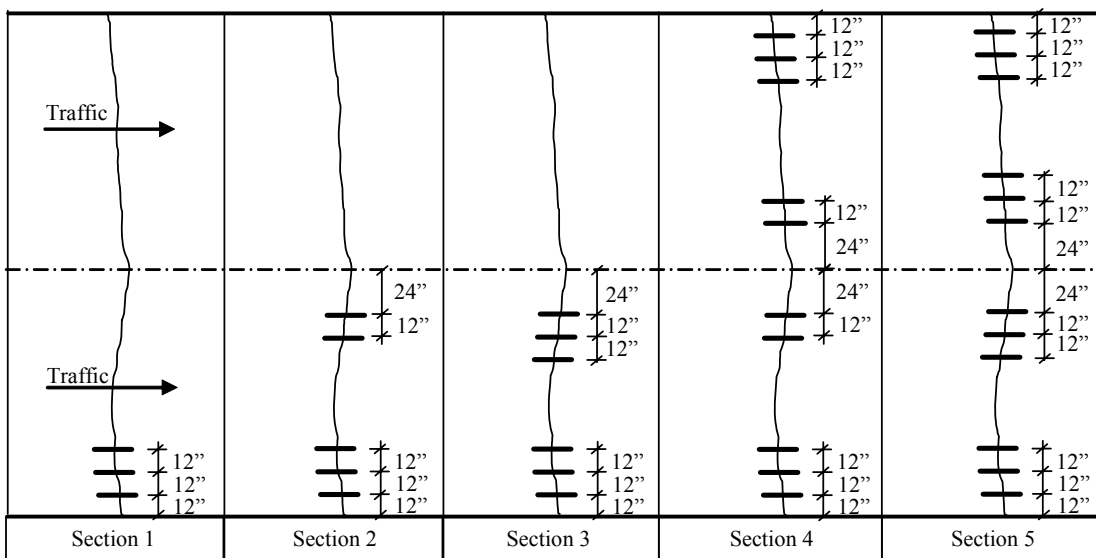
Figure 1. TH 52 test section retrofit dowel bar patterns.

The layout of the five test sections is shown in Figure 1. Retrofit dowel bar pattern variations included combinations of three, two, or no bars in the wheel tracks for both the driving and passing lanes. Dowel to dowel spacing in the wheel tracks was 300 mm (12 in.). For comparison, a control section containing no retrofit dowel bars, but sealed mid-panel cracks, was monitored as part of the study.

Each test section is approximately 322 m (1,056 ft) long and is divided into two subsections. Transverse mid-panel cracks in the first subsection (containing approximately 20 panels) were retrofit with dowel bars 38 mm (1.5 in.) in diameter by 380 mm (15 in.) long. Transverse mid-panel cracks in the second subsection were retrofit with dowel bars 38 mm (1.5 in.) in diameter by 457 mm (18 in.) long. Each subsection also began with the first four mid-panel cracks retrofit using a polymer-modified quickset patching (PMQP) backfill mortar material. The remaining retrofit dowel bars in each subsection were installed using Mn/DOT's high early strength concrete repair patching material, designated as Mn/DOT 3U18. The primary reason for testing two types of backfill mortar is that Minnesota's extreme climate places severe demands on such materials. Pavement temperatures in Minnesota range from  $-40\text{ }^{\circ}\text{C}$  to  $55\text{ }^{\circ}\text{C}$  ( $-40\text{ }^{\circ}\text{F}$  to  $131\text{ }^{\circ}\text{F}$ ), and frequent freezing and thawing conditions in the winter and spring necessitate the use of chemical deicers. In addition, retrofit dowel bar projects typically require minimal traffic disruption, therefore requiring early strength gain of the mortar. Discovering backfill mortars that meet early strength and long-term durability criteria is the key to developing best practices for this pavement rehabilitation technique. The performance of the retrofit mortars on this project will be discussed shortly.

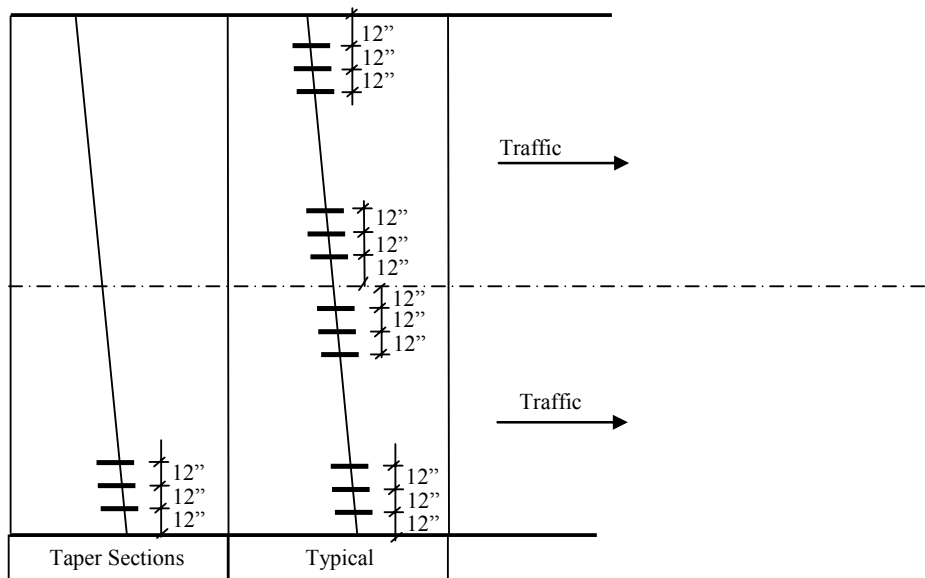
Figure 2. TH 12 test section retrofit dowel bar patterns.

This project was designed to study the performance of retrofit dowel bars installed across significantly faulted transverse joints. The project included two retrofit dowel bar patterns. The layout of the dowel bar patterns is shown in Figure 2. Short sections of tapering lanes contained transitions from three dowel bars in the outside wheel track, to three dowels in both the outer and inner wheel tracks. Otherwise the latter configuration (six dowels) were retrofit into both the driving and passing lanes. Dowel to dowel spacing in the wheel tracks was 300 mm (12 in.). The first dowel from the edge of the driving lane shoulder was placed at 300 mm (12 in.). The slots were formed using a milling machine, rather than the standard method of saw cutting and chipping. All retrofit dowel bars were 38 mm (1.5 in.) diameter by 457 mm (18 in.) long, and installed using Mn/DOT 3U18 patch mix backfill material.

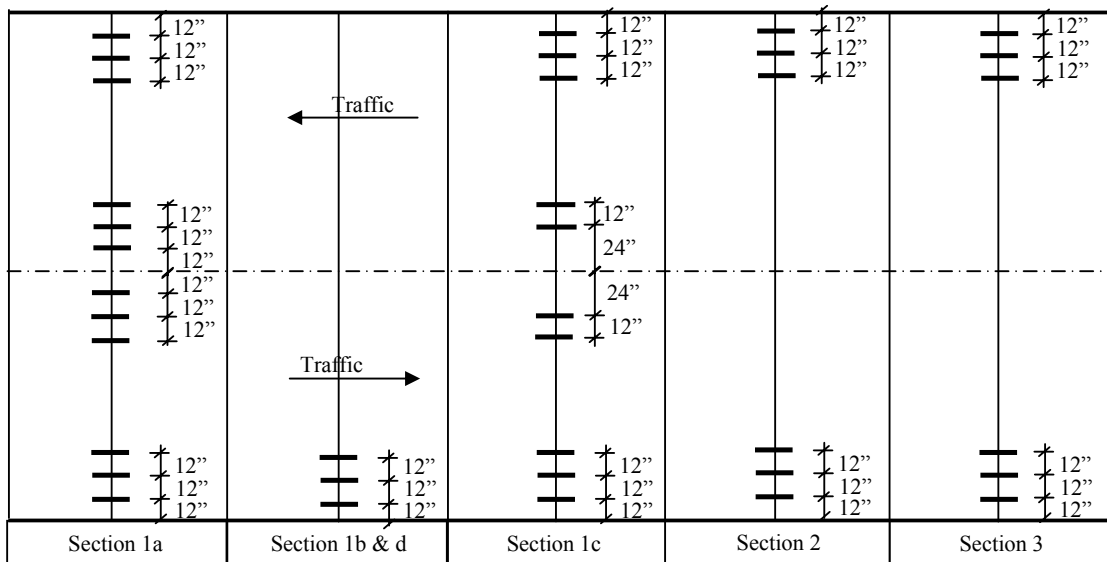
**Figure 3. TH 23 test section retrofit dowel bar patterns.**

The retrofit dowel bar pattern variations in this project included combinations of three, two, or no bars in the wheel tracks for both the driving and passing lanes. The layout of the three test sections is shown in Figure 3. Test Section 1 consists of 160 total joints utilizing a repeating pattern of 20 joints of the sequences 1a, 1b, 1c, 1d as shown in Figure 3. Retrofit dowel bars were 380 mm (15 in.) long and 38 mm (1.5 in.) diameter. The backfill mortar type was Mn/DOT 3U18. Test Section 2 consists of 80 total joints, with 40 joints using rapid set mortar (RSM) backfill, and 40 joints using Mn/DOT 3U18 patch mix. The retrofit dowel bars in this section were 380 mm (15 in.) long and 38 mm (1.5 in.) diameter. Test Section 3 also consists of 80 total joints, utilizing a repeating pattern of 20 joints with 325 mm (13 in.) long retrofit dowel bars, then 20 joints with 380 mm (15 in.) long dowel bars. All of the dowel bars in this section were 38 mm (1.5 in.) diameter and the backfill mortar was Mn/DOT 3U18. Dowel to dowel spacing in the wheel tracks was 300 mm (12 in.). For comparison, a control section containing no retrofit dowel bars, but a diamond ground surface, was monitored as part of the study. Additional information on the layout and construction of TH 23 test sections can be found in a report by Embacher (7).

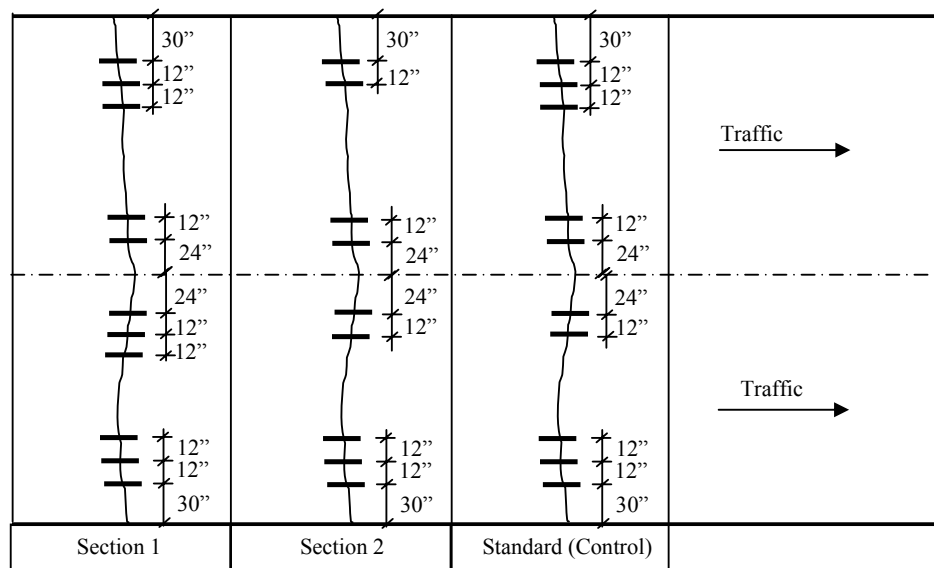
**Figure 4. I-90 Test section retrofit dowel bar patterns.**

The test sections in this project were designed to study the configuration and number of retrofit dowel bars necessary to achieve long-term load transfer across faulted transverse mid-panel cracks. The layout of the two test sections is shown in Figure 4. Retrofit dowel bar pattern variations included combinations of two or three bars in both wheel tracks of the driving and passing lanes. Test sections 1 and 2 are each ten panels long (in both eastbound and westbound directions). All retrofit dowel bars were 38 mm (1.5 in.) by 380 mm (15 in.) long. Dowel to dowel spacing in the wheel tracks was 300 mm (12 in.). The first dowel from the edge of the driving lane shoulder was placed at 760 mm (30 in.).

All retrofit dowel bars on this project were installed using a PMQP mortar mixture. It was noted during construction that the existing reinforcing steel in the pavement was causing rapid wear of the saw blades used to form the slots. Therefore, many of the retrofit dowel bars on this project were placed 6 mm (0.25 in.) higher than the standard dimension of half the thickness of the pavement.

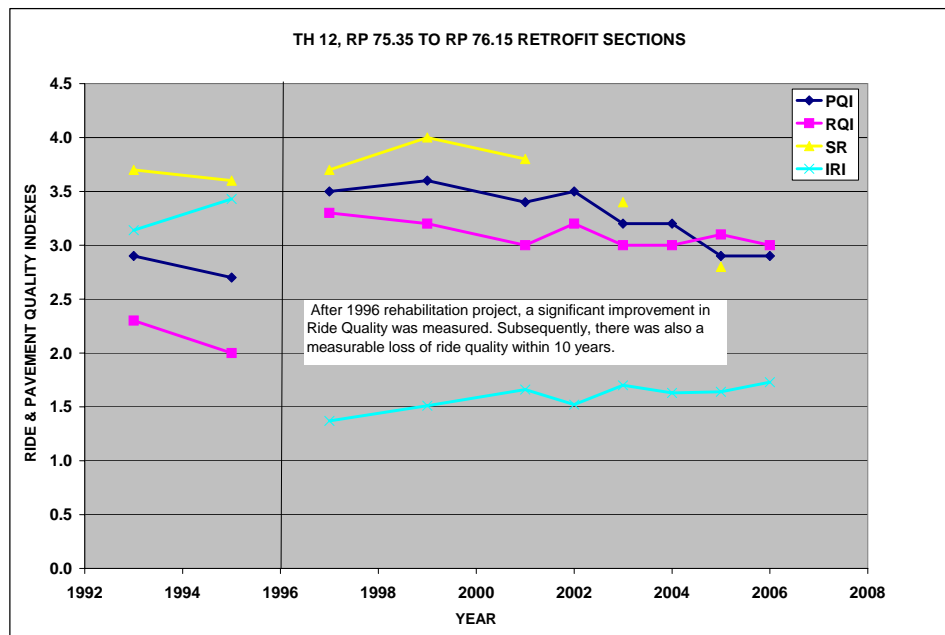
Figure 5. TH 12 pavement quality index trends.

Figure 5 shows a performance decay model for the TH 12 project. The rate of decay can be significantly influenced by the residual life and existing condition of the concrete prior to

rehabilitation. It is sufficient to note that there was a significant increase in ride quality after the retrofit project was completed, and after 10 years of service, the PQI is still above the value before the retrofit project was done. Unfortunately, the network-level data available for the other projects in this study did not allow for the establishment of similar decay curves at this time.
